The University Church of Saint Mary the Great

The 1788 Peal Board

The Restored Peal Board

Some Notes on its Construction and Conservation

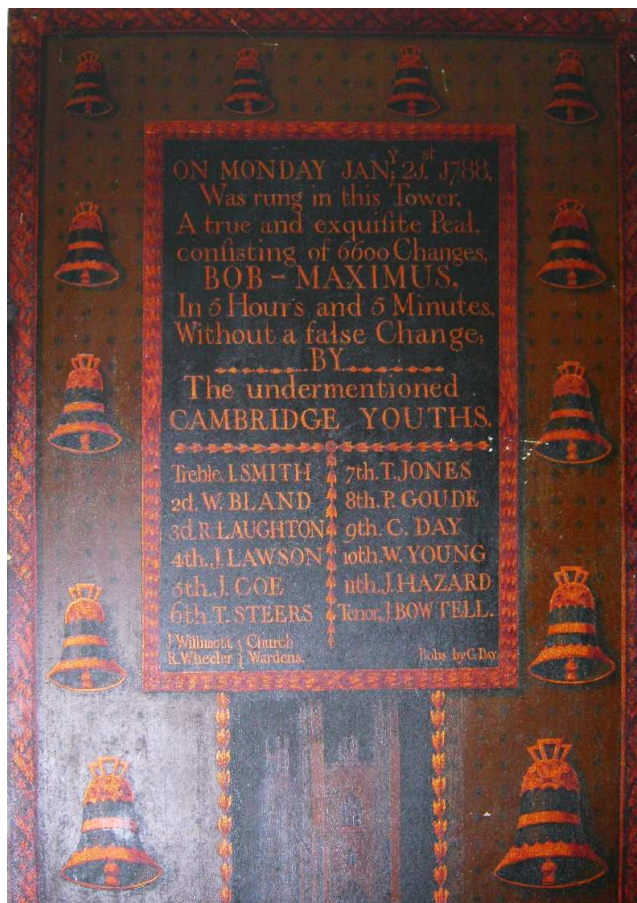
The photograph below was taken in the ringing room of Great S. Mary's on 2 April 2009, shortly before the room was refurbished as part of the project to install a new ring of 13 bells. The board is very dark and there is no hint that much of the background is a light blue-green colour. It is hard to see many of the details, especially those in the painting of the church tower at the bottom.

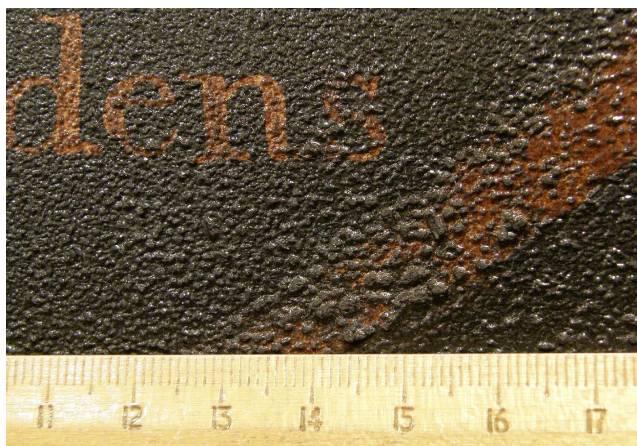
Fig. 8 — Example of Serious Alligatoring

These lights give off more ultra-violet light than incandescent bulbs and ultra-violet light is known to darken varnish. Such lights are now frowned upon by art galleries and museums.

Varnish is less elastic than oil paint and while small changes in dimension caused by variations in temperature and humidity can be accommodated by paint, varnish tends to crack and to coalesce into blobs. The appearance can be a little like that of an alligator's skin and the effect is sometimes known as alligatoring.

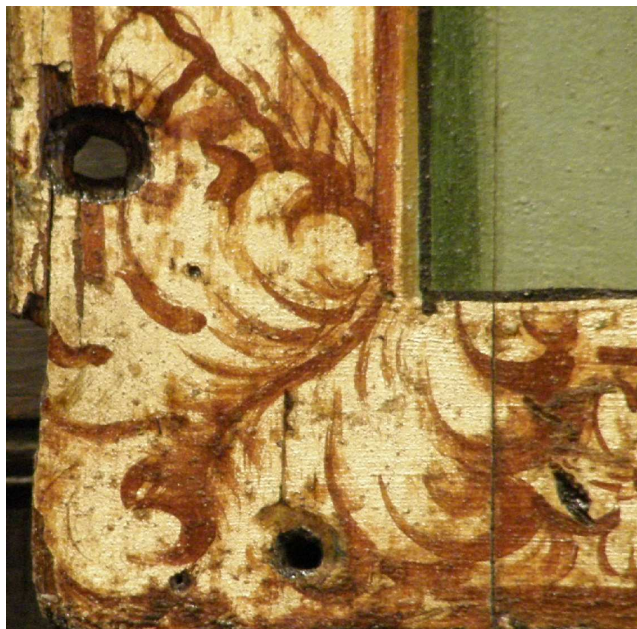
Fig. 9 — Damage to the Bottom Left-Hand Corner

More serious damage was caused by drilling holes through the mahogany so that screws could be used to secure the board to the wall. Most of these holes were near the edge of the board and there were some serious splits.

When the ceiling was lowered in 1952, the board had to be lowered too and a new set of holes was drilled into the mahogany. As a result of incompetent measuring, a single screw supported half the weight of the board. Unsurprisingly, this screw caused the most serious split.

In the bottom left-hand corner of the board a small piece of the mahogany had split off and was missing. This damage is shown in the photograph in Fig. 9 and two large holes are also clear. The upper one is associated with a split in the wood.

The larger splits in the wood were repaired simply by using a water-based glue. The missing fragment from the bottom left-hand corner of the board was made good by carefully shaping a new piece of mahogany and gluing it to the board.

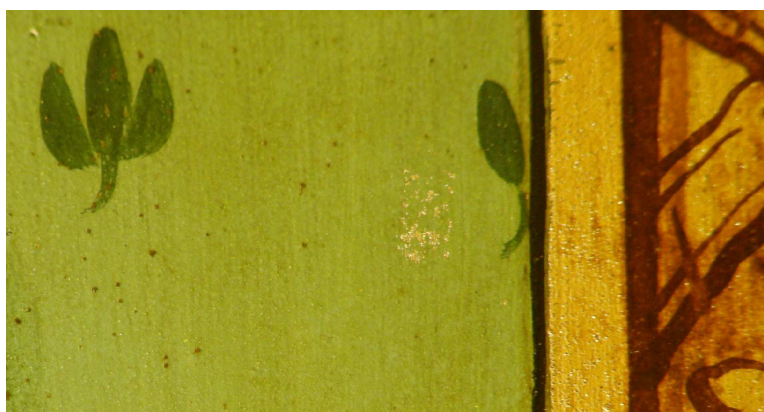
Fig. 12 — Misplaced Gold

There are a number of such imperfections in the restored peal board and it is of interest to draw attention to some of them. A typical example is illustrated in Fig. 12 which shows a small detail of the board near the top right-hand corner. A little patch of gold can be seen which is clearly out of place.

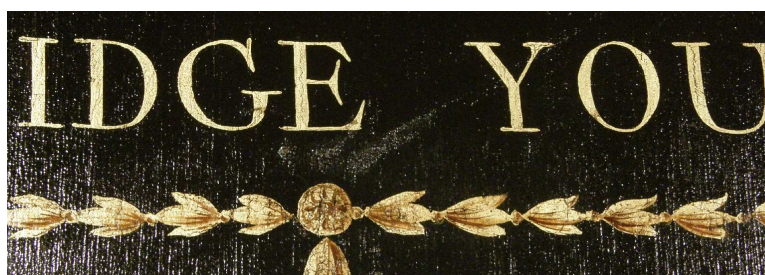
Fig. 13 — A Painted-Over Run of Glue

Fig. 13 shows a small blemish close to the middle of the board. There is a curious smear which runs from just below the letter E almost as far as the letter Y.

This smear is below the surface of the paint and it is possible that when the panels were glued together a small run of glue spread over the board and was not scraped off. This glue remained on the board and was covered in primer and then paint.

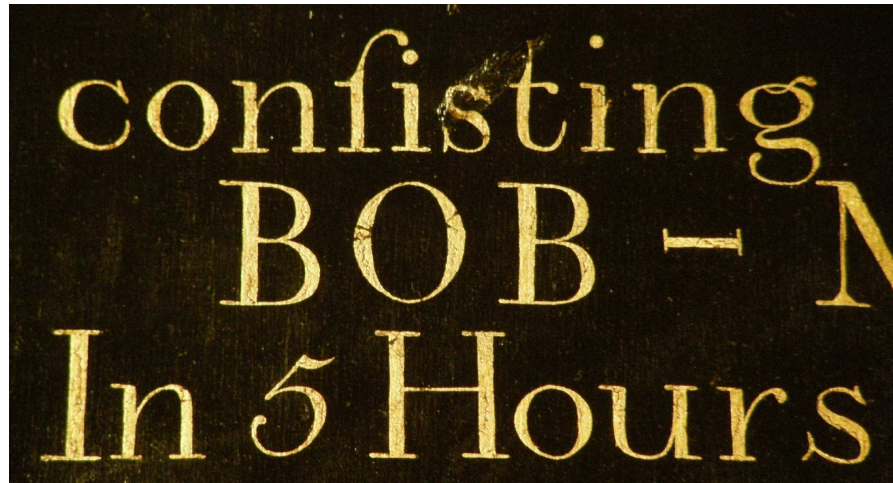
Fig. 14 — A Scratch and Poorly-Applied Gold Leaf

In Fig. 14 there are two imperfections. There is a smear across the 'st' in 'consisting' and the gold leaf in the letter O of BOB is broken up.

The smear in this case is a scratch. It is possible that the artist knocked something against the paint when it was still wet. The gold leaf for the lettering has been applied over this scratch.

In the letter O of BOB the gold leaf has not been applied very well. Gold leaf is very difficult to work with partly because it is so light. Ideally, it should be applied in a totally draft-free room because the slightest movement of air can fold a piece of gold leaf over on itself and make a mess.

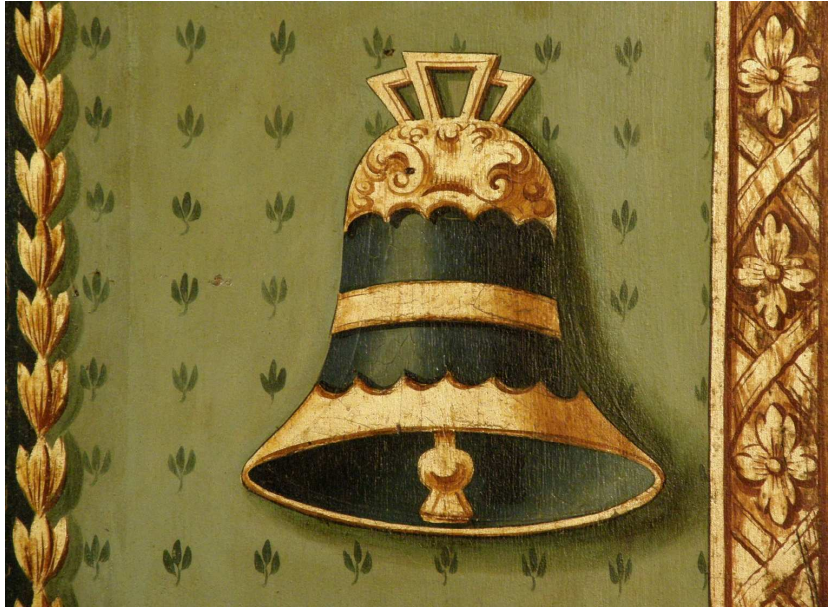
Fig. 15 — Alteration to the Largest Bell

On close examination, one can see what almost looks like a curved crack in the bell running down the left-hand side. The crack is parallel to the left-hand margin of the bell and appears to form the original margin. The implication is that the bell was originally drawn about four-fifths of its final size.

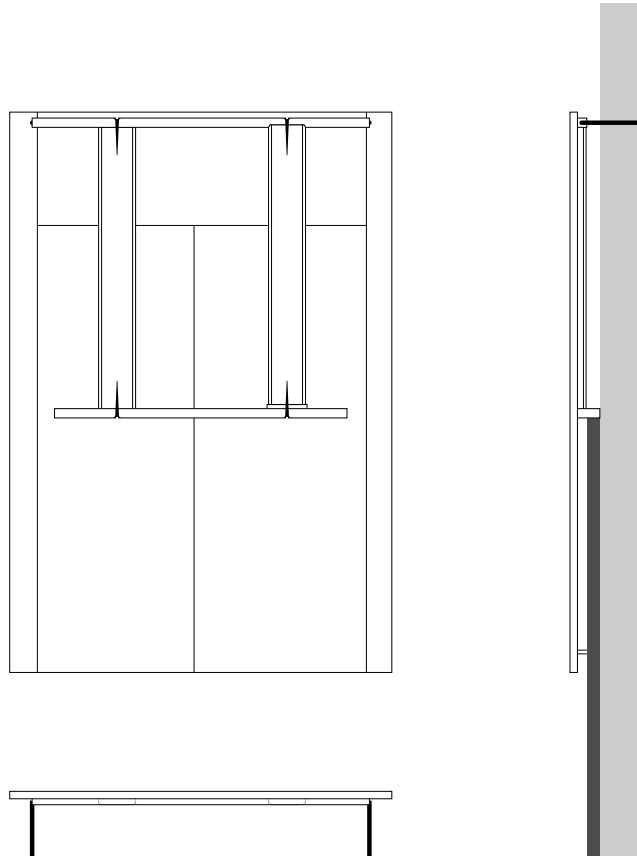
Fig. 16 — First-Angle Projection of the New Hanging Arrangement

It has been noted that much of the damage to the peel board was the result of poor hanging. For most of its life the board was held in place by iron brackets and screws. Holes were drilled through the mahogany board and since the artwork extends to the very edge of the board these holes went through the gold leaf too.

A new hanging arrangement was designed by Bo Killander and this is illustrated in the drawings in Fig. 16 and in the photographs in Figs 17 and 18. No fixtures are attached directly to the mahogany board.

Two new battens were prepared and these were fixed to the original vertical chamfered pine battens by screwing into the end-grain of the original battens. The two new battens show up clearly in Fig. 17. Note that the lower batten required a packing piece on the right and that the upper batten required a small section to be cut out on the right.

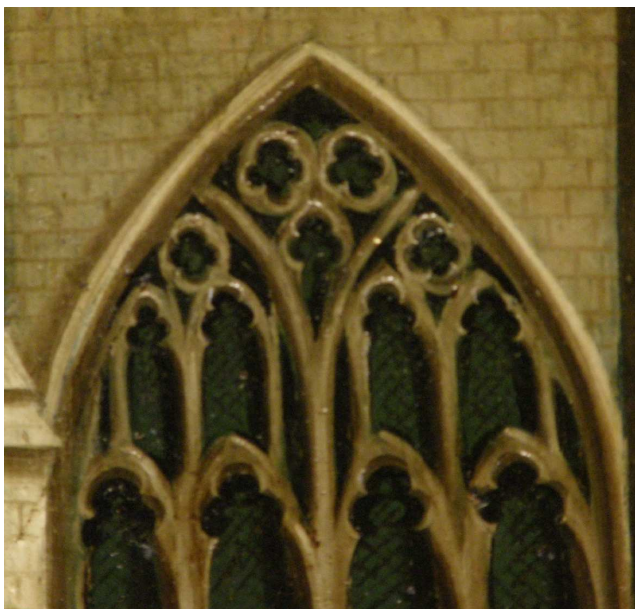
Fig. 23 — The West Window as painted

The artist has the enveloping arch a little too pointed and the details under this arch show poor attention to structural considerations. At the bottom of Fig. 22, there are four small arches, and four mullions rise up from the centres of the tops of these arches. The corresponding mullions in Fig. 23 rise up from points which are off-centre with respect to the tops of the arches and this is structurally unsound.
