# INVESTIGATION REPORT

## LANL Investigation of a Laser Eye Injury

An Accident Investigation Team (the Team), appointed by LANL Director G. Peter Nanos and working from July 19 to August 27, 2004, interviewed personnel, reviewed documents, and characterized systems and conditions in room 106. The PI reported that he was operating L1 with the Q-switch trigger cable disconnected from the Stanford Research Systems pulse generator. The Team's collected evidence confirmed that L1 could not lase under those conditions. However, because L1 *did* emit laser light on July 14, the Team believes, based on its collected evidence, that the laser was operated in one of three possible lasing modes.

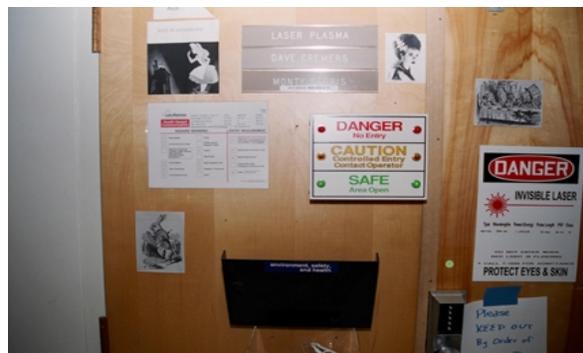
Figure 2.4. Laser warning lights on the hallway door leading into the laser lab in room 106.

- L2 was introduced into the lab without being interlocked to prevent personnel from being inadvertently exposed to laser-induced optical radiation hazards.
- Warning lights on the lab doors were improperly used.
- LEP requirements were not adhered to.
- Options for remotely viewing particles were not exercised.

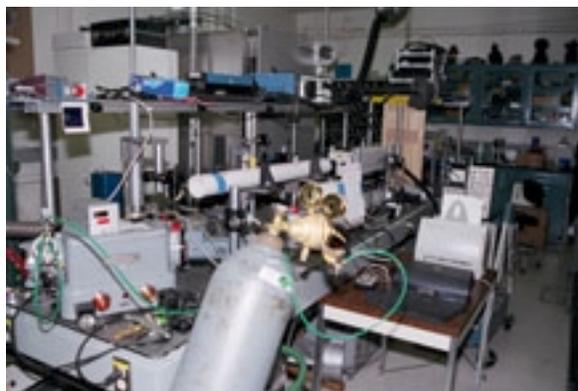
The Team observed a general state of poor housekeeping in room 106 (see Fig. 2.5). The area around the optics table was partially blocked by diagnostics on an additional table that had been positioned against the optics table and also by a gas cylinder and a vacuum pump. LEP was available for use throughout the lab, although the optical density (OD) rating labels on some were worn and therefore difficult to read.

Figure 2.5. Poor housekeeping in room 106.

- The PI failed to fully implement the requirements of the laser LIR, Notice 139 and Notice 142.
- The PI failed to maintain a work environment that demonstrated good housekeeping and that allowed for sufficient egress, in spite of the fact that the C-Division leader shut down the division for all-day housekeeping April 2, 2004.

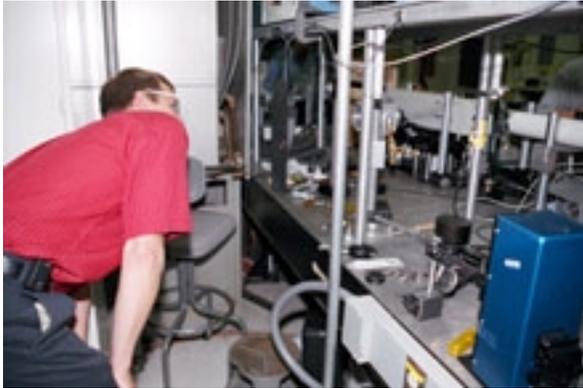
After turning the room lights out, the PI removed the beam stop and saw particles suspended inside the target chamber. S1 was now standing next to him. When the PI told her to look, she stepped forward and bent down to view the target chamber. She immediately saw a flash and a reddish-brown substance floating in her left eye. The reddish-brown floater was obscuring her vision. A re-creation of S1's position when looking into the target chamber is shown in Fig. 2.10.

*Figure 2.10. A team member demonstrates S1's position when she looked into the target chamber on July 14.*

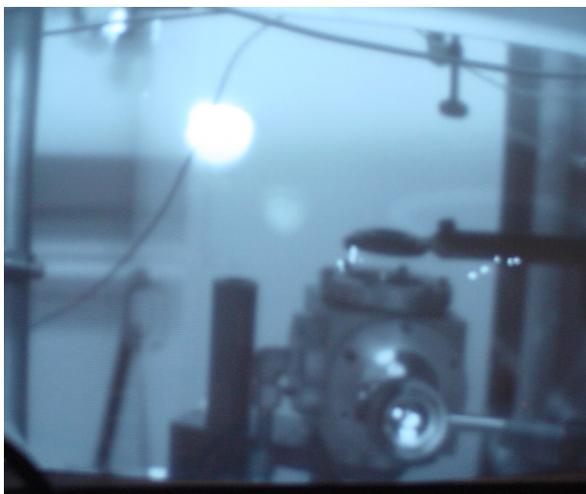
Because L1's beam entered the focusing lens low, off-axis, it was turned upward through the chamber and, with the beam stop removed, hit the metal cabinet behind the fume hood 36 inches from the target chamber's rear window. S1's eye intersected this main beam path between the table and cabinet. Furthermore, the cabinet clipped the beam, and part of the beam impinged on a pressure gauge mounted on the back wall 59 inches from the floor and 83 inches from the target chamber's back window. After passing through its focal point in the target chamber, the beam expanded and was about 5 inches in diameter on the cabinet. (See Fig. 3.1)

*Figure 3.1. IR image of the transmitted laser pulse image on the back wall.*

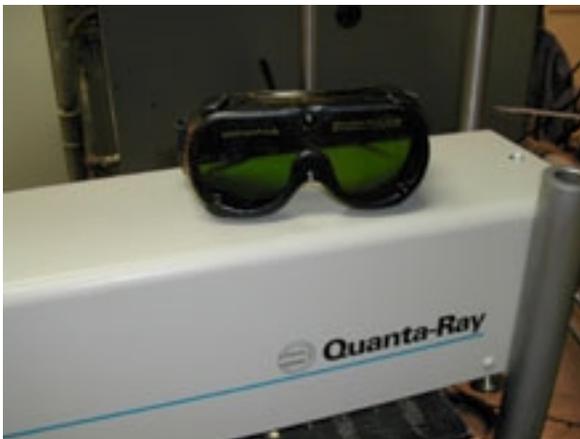
The PI did not routinely wear LEP (see Fig. 4.2). After aligning a laser, the PI was confident in his knowledge of the laser beam's position and character-

Figure 4.2. LEP available for use in room 106.

istics. He trusted his ability to avoid the hazard. He transferred this knowledge and practice to his co-workers and students, including S1. As a result, S1 was injured when an unexpected and unidentified hazardous laser beam hit her left eye during Class IV laser operations.

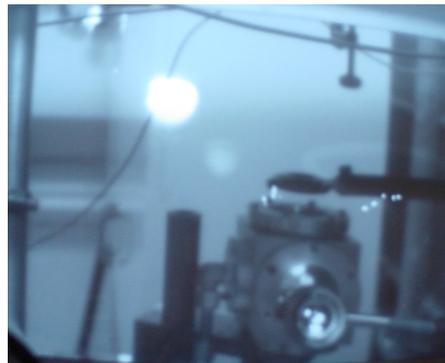
Figure 6: IR image of transmitted laser pulse image on back wall.
