Curfew Tags: Mechanical Fatigue Tests

Reference: DPC/010/Fatigue/Issue1

James Dean

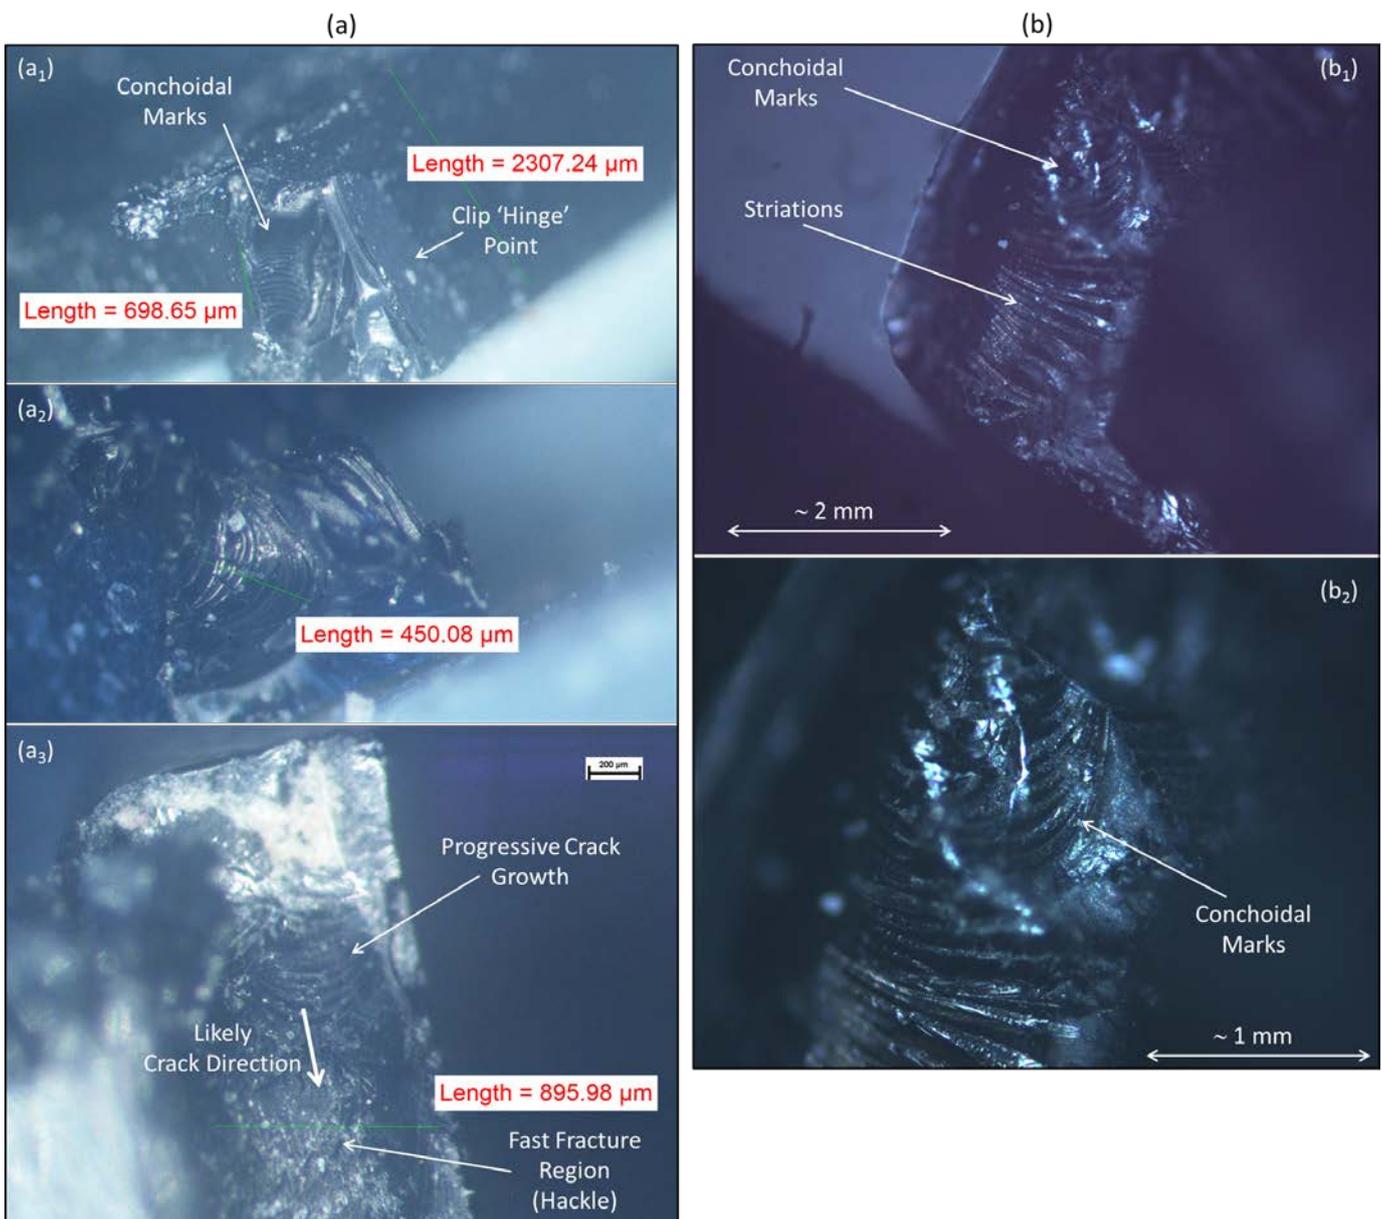
The micrographs in Fig.5 were obtained using optical light microscopy by James Dean at (a) Surescreen Scientifics Division (SSD) in Derby on Friday the 11th July in the presence of Professor Ross Anderson, James Campbell, Troy White, Paul Fearnley and Ray Davison, and at (b) Cambridge University by James Dean on Tuesday the 22nd July in the presence of Professor Ross Anderson and James Campbell. The 22nd July event was filmed by James Campbell. They are fracture surfaces from (a) the curfew tag with PID serial number PIDGCS 341525 and (b) the curfew tag with serial number PIDGC 444467. Specifically, these tags are those that were worn by Special Z in (a) 2011 and (b) 2013. After failing, both tags were analysed by James Campbell at Surescreen Scientifics Division. The corresponding SSD reports are (a) C2268 and (b) D1031. In both cases James Campbell reported the presence of conchoidal marks which is consistent with my own microscopy.

Figure 5: Optical light microscopy micrographs of (a) PIDGCS 341525 and (b) PIDGCS 444467 fracture surfaces

The conchoidal marks and the region of fast fracture in Fig.5(a₃) are consistent with those observed in Fig.2 and Fig.3. They appear therefore to show evidence of progressive crack growth. Since the conchoidal marks and striations are numerous, it would have to be assumed that a significant number of loading events occurred. This

naturally implies that they occurred at a load that was insufficient to cause complete and immediate failure of the clip, although one could not say what loads exactly.

There are also some similarities with the Wallner lines that are shown in Fig.4 – notably in Fig.5(b₂) and I cannot reliably confirm that the conchoidal marks in Fig.5 are not Wallner lines. However, their presence is favoured in materials that are stiff and brittle, while the polycarbonate clips in this study have a low stiffness (~100× less than steel) and exhibit extensive plasticity during failure (§6.0).

The conchoidal marks in Fig.5 resemble fatigue crack growth marks such as those shown in Fig.2 and Fig.3. Their location is consistent with our understanding of how the loads are distributed during loading of the strap. Our understanding has been aided by some simple finite element modelling. We have attempted to recreate the features shown in Fig.5 by conducting our own fatigue tests. The applied cyclic loads were designed to simulate the everyday activities of Z. They included therefore some simulated prayer cycles, some simulated cycling cycles and some simulated football cycles. The tests were accelerated in order to induce approximately 6 months' worth of loading. Some further, more vigorous loading cycles were imposed also. These were designed to simulate accidental snagging events. It is accepted that the ordinary loading cycles incurred by Z's tag cannot be reproduced to high precision in the laboratory. The same is true of an accidental snagging event. Our simulated loading cycles are approximations only.

We found in all instances that we could not generate the features shown in Fig.5. The residual strength of the tags remained comparable to the values recorded for tags that had not been fatigue tested. One has to assume therefore that we did not induce fatigue damage, and this is consistent with the fractography. The effect of an initial (sharp) partial-crack (such as those seen on page 17 of D0131) on the fatigue performance of these tags has not been studied, but it could be important.

James Campbell has previously said that it is very difficult to break just a few of the clips if a significant and deliberate load is applied to the strap (paragraph 13 of reportC2268). Might this suggest therefore that the clip was damaged progressively and over a long period of time? This is consistent with the fracture surfaces in Fig.5.

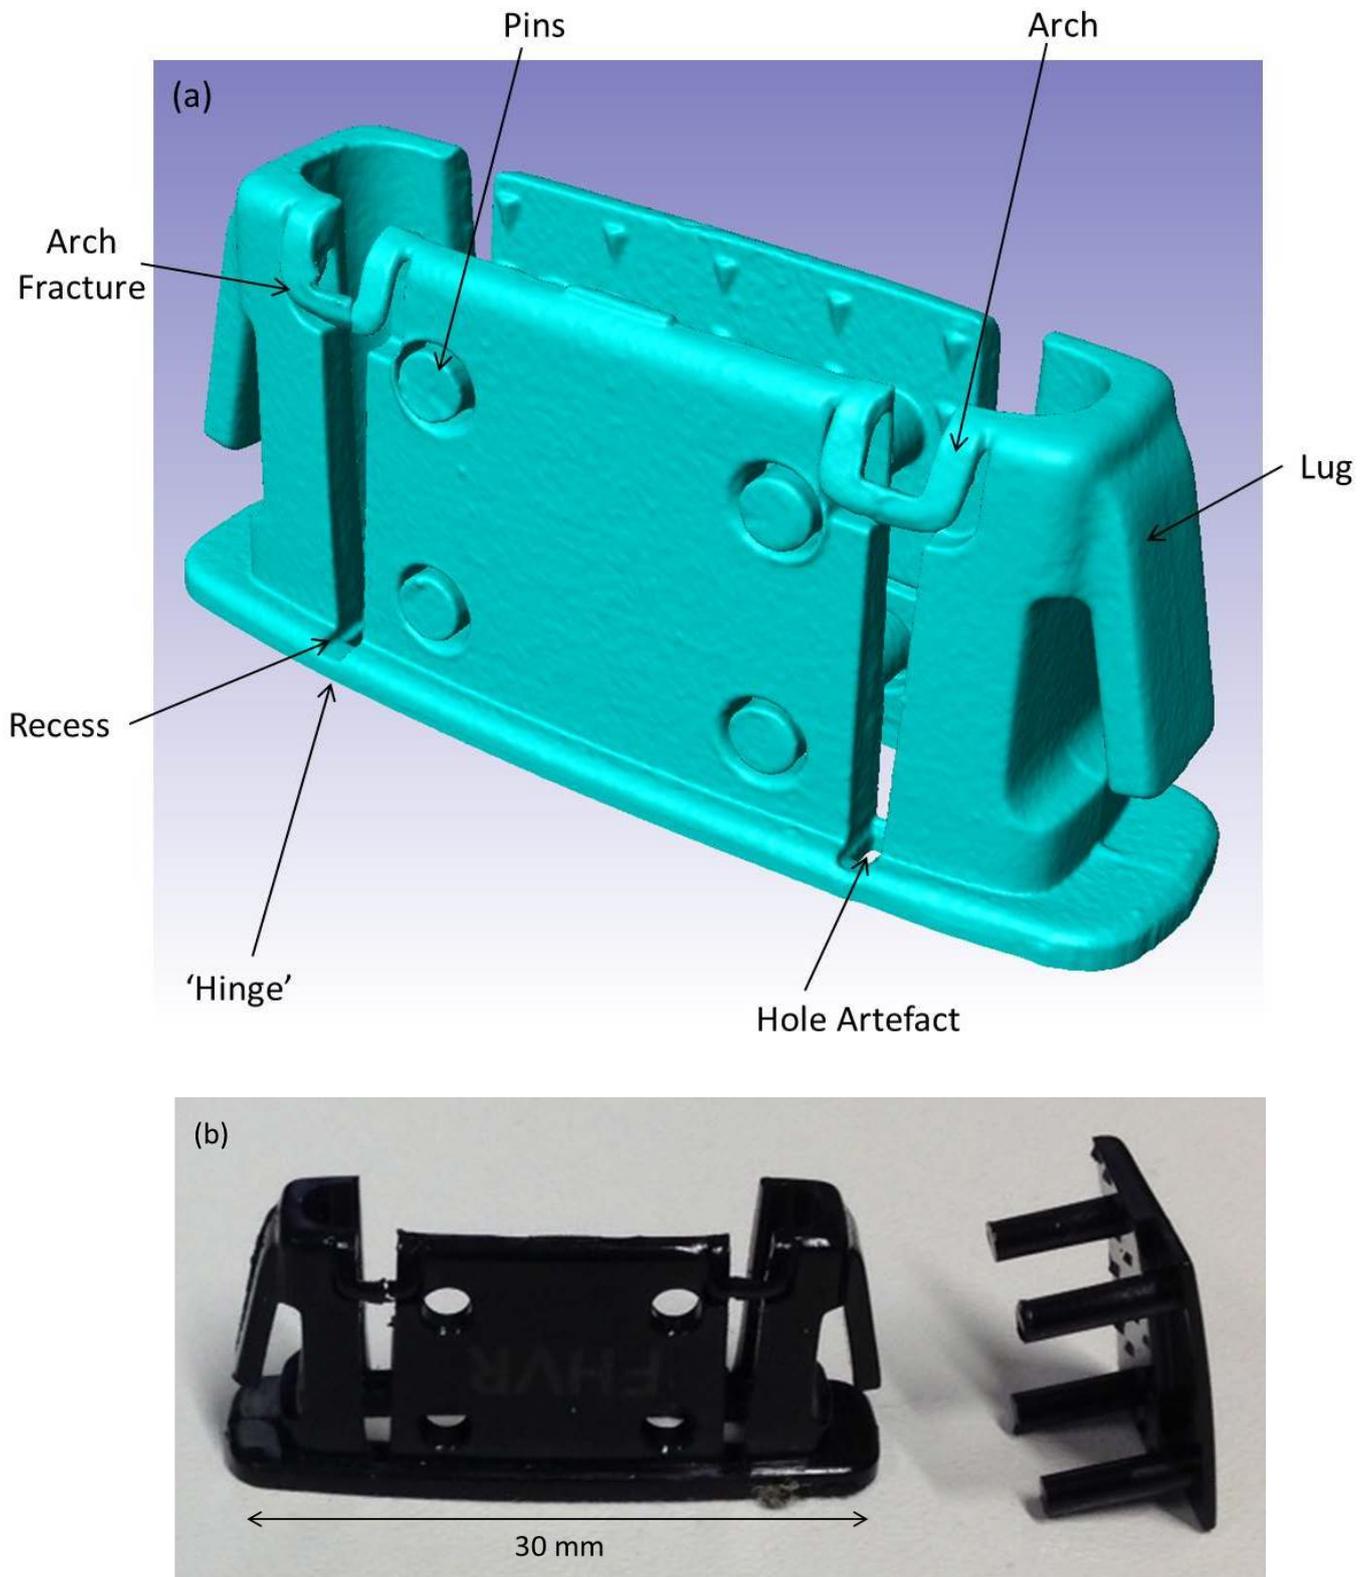
The clip geometry is shown in Fig.8(a). It is a 3D reconstruction obtained from X-ray microtomography radiographs. There is a fracture in the left-hand uppermost arch – believed to have occurred while Professor Ross Anderson was handling the tag. There appears also to be a hole in the lower right hand hinge location. This is an artefact from the

reconstruction process. Ignore it. The recess where the 'Hinge' is located is however real, and it is there to encourage failure in this location. The same is true of the two uppermost arches which are approximately 0.5 mm thick. The clip is made from two separate components – shown in the photograph in Fig.8(b) (although sometimes there are three components and it is not clear why).

Figure 8: A 3D reconstruction of the clip assembly is shown in (a) along with some of the relevant features. The two separate components that comprise the assembly are shown in (b). The clip in (a) is not the same clip shown in (b).

I also note that the upper two arches (see Fig.8(a)) are very fragile. Professor Anderson appeared to fracture one while in my presence and without exerting much load. There was an audible crack while he handled the tag. I then X-rayed the tag – without removing the clip assembly from the tag – and found that one of the arches was indeed fractured. The scan in Fig.8(a) is from Professor Anderson's tag. The possibility that these two arches can fracture during installation of the tag should therefore be explored. My handling of the clips and my preliminary simulations suggest that this is indeed possible. I am not aware if this has previously been considered and, by their own admission, SSD cannot remove the clips from the tag without breaking the arches. I suggest therefore that a number of assembled tags and straps be analysed with X-rays. It also seems apparent that these two clips could fracture without causing any significant misalignment between the optical fibre and the light receiver. In my opinion, even if these arches had fractured, I would not expect to see any significant reduction in the load required for failure when the tags are loaded axially. Their contribution to this load is, in my opinion, very small. It would have been very helpful to have received the spare sets of unassembled clips and tags as we initially requested.

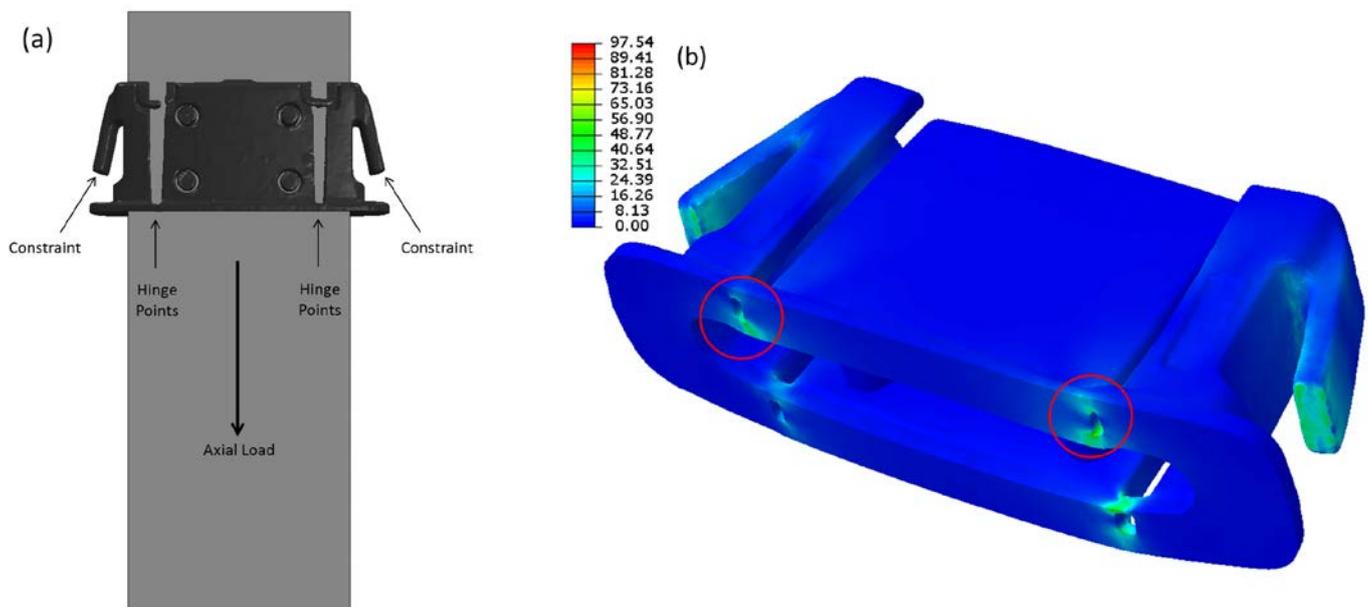
The rubber strap is fixed to the clip assembly by the four pins. When the strap is loaded axially – as in Fig.9(a) – the load is transferred via the pins to the clip assembly. Since the lugs are constrained from moving by retaining seats,

the applied load is accommodated in the upper two arches and across the lower two 'hinge points'. This type of loading condition induces bending (and some shear) in the upper two arches and in the lower two hinge points. This is an important point, since even small amounts of curvature in bending beams induces very large stresses in the surface regions.

A preliminary finite element analysis indicates that the bending stresses are highest in the hinge points at the back of the clip assembly. This can be seen in Fig.9(b) which shows the von-Mises (equivalent) stresses (in MPa) in the clip assembly when the strap is displaced axially by 0.5 mm. These preliminary simulations suggest that this is the location where fracture is first likely to occur. For reference, these locations are the hinge points nearest to the outward facing strap surface. The model assumes (very reasonably) that the polycarbonate stiffness (Young's modulus) is 2 GPa. One should note that the stress fields shown in (b) are affected by the presence of the holes in the hinge points which are an artefact of the reconstruction process (which could be fixed with time), but the conclusions drawn about the load distribution are unlikely to change.

Although preliminary, these early simulations already convey important information about how the tags are loaded and the likely locations for failure. I specifically note that in all of the cases we've seen the tags do fail in these locations and there is also evidence of partial cracking in James Campbell's report (pages 16 and 17 of D0131) in the locations circled in Fig.9(b). Such partial fractures are extremely important since if they occur and are unknown about then it is perfectly rational for these cracks to continue to grow under the action of an applied cyclical load, and at a load level much less than the level required to fully break an intact clip. This is the very definition of fatigue failure. This type of failure would also be favoured if the existing crack were sharp, and the images in D0131 are of sharp-tipped hairline fractures.

Figure 9: The reconstructed clip assembly is shown in (a). Included is a strap, to which an axial load is applied. Preliminary finite element simulations in (b) already indicate that high bending stresses develop in the lower hinge points. The simulations also suggest that the lower hinge points are likely to break first although the 'hole' artefacts would need to be removed in any future simulations to provide definitive proof.

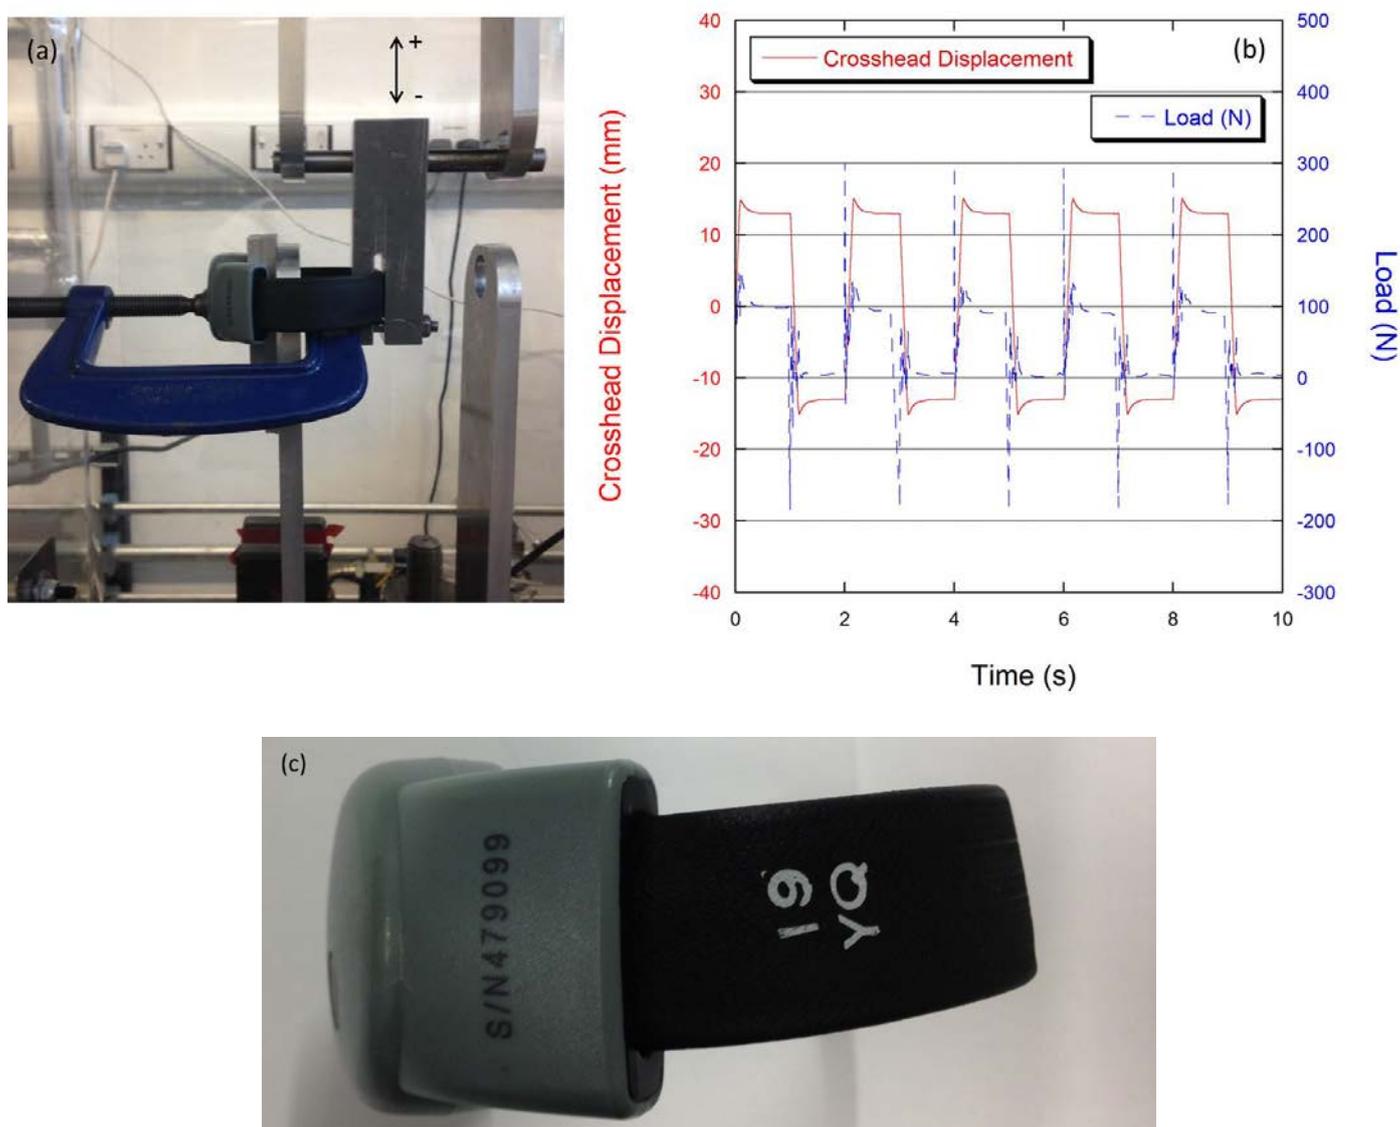
TAG 6: Constant amplitude fatigue test with a square wave amplitude history with the tag oriented in the manner shown in Fig.15(a). In this condition, the applied load is distributed non-uniformly through the clips, such that any damage is likely to be located in the lower parts of the clip as we view it in the figure. The imposed displacement history is shown in Fig.15(b). The measured load history is included in the figure. The peak applied load is ~300 N (~30 kg). This corresponds to a significant snagging event. 3640 of these events were simulated – i.e. ten snagging events per day for one whole year. The compressive loads in Fig.15(b) are generated from the downwards momentum of the crosshead during testing. They can be ignored.

The image in Fig.15(c) shows TAG 6 after the completion of the test. There is a clear amount of permanent distortion, and the strap now exits the tag at an angle. There were no obvious indentations in the strap edge.

Figure 15. The testing arrangement employed for the off-axis TAG 6 fatigue test is shown in (a). The imposed square-wave amplitude history for the tests conducted on TAG 6 and the corresponding (measured) loads are shown in (b). The first ten seconds of the test are shown. 3640 of these cycles were imposed in total. TAG 6 after testing is shown in (c).

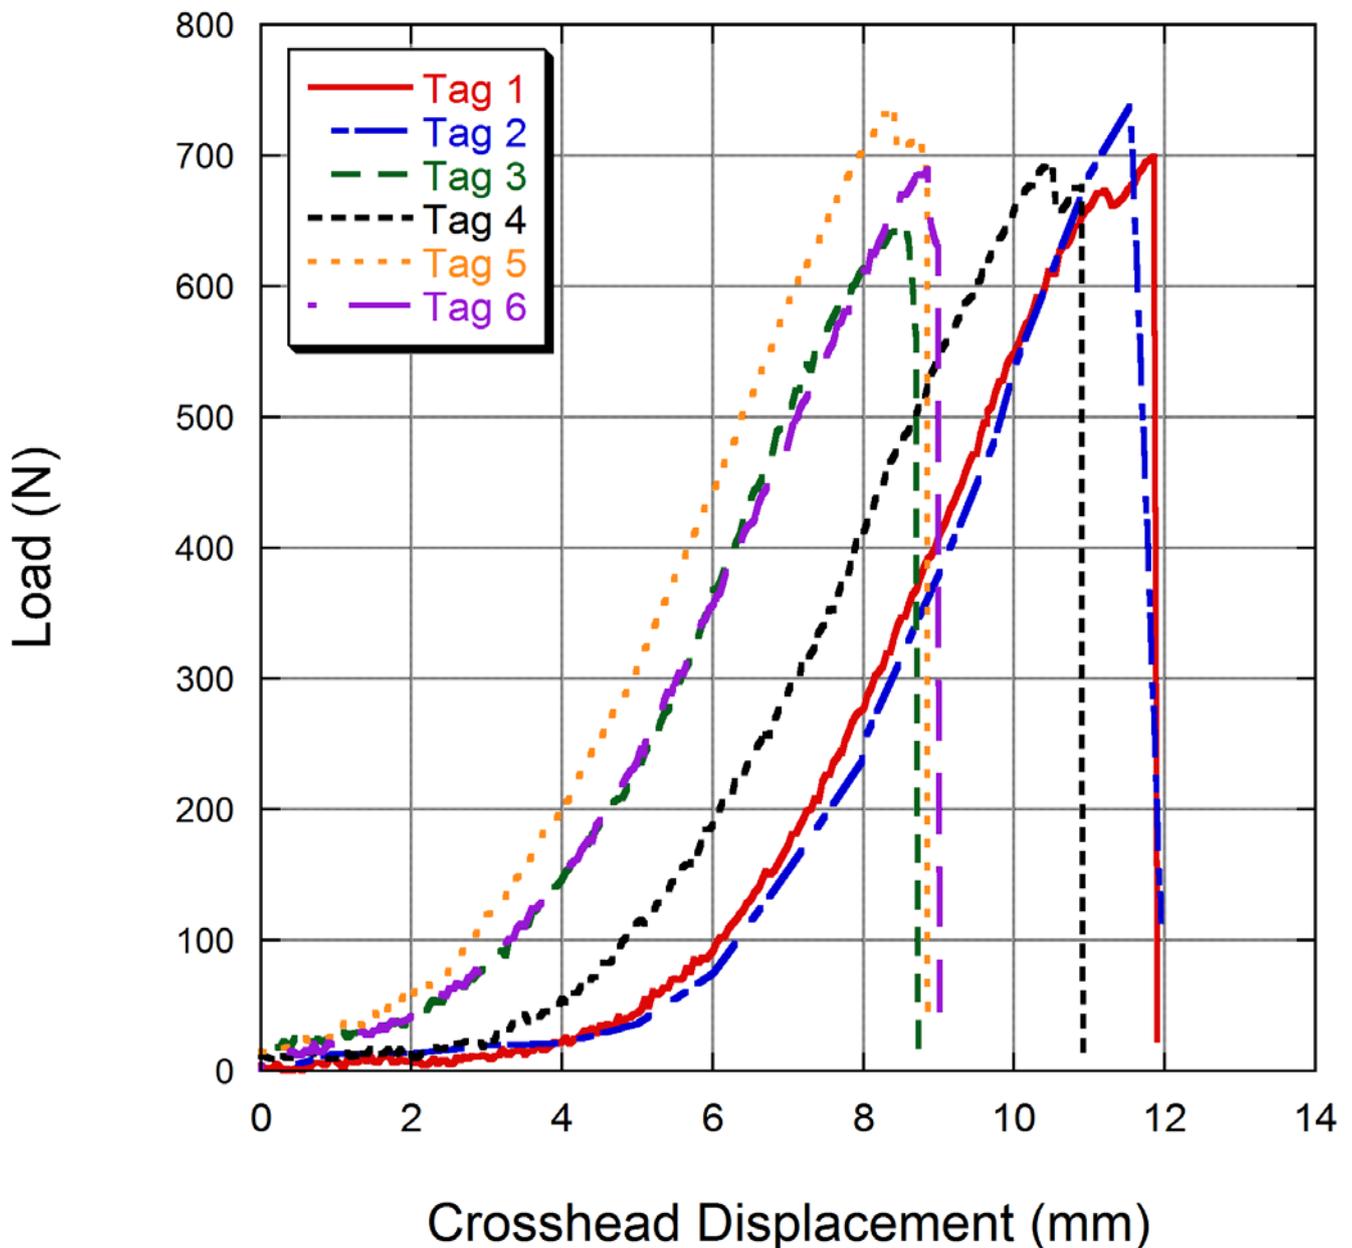
The mechanical test results are shown in Fig.16. They are curves of crosshead displacement (see Fig.10) versus load. Each of these curves was obtained from a monotonic loading test – i.e. the load was steadily increased until the tag failed. TAGS 3, 4, 5 and 6 were first subjected to the fatigue tests described in §4.2.

Figure 16: Measured load versus crosshead displacement data for TAGS 1 to 6. These data are from monotonic loading tests. TAGS 3, 4, 5 and 6 were subjected to the cyclic loading histories described above.

In each case, the load at failure was ~700 N (or ~70 kg). The only exception to this was TAG 3 with a failure load of ~650 N. However, these values all lie within the range specified by Surescreen Scientifics Division – even TAG 6

(Fig.15(c)) which displayed clear evidence of permanent distortion after testing. Although limited in number, these data suggest that any damage from fatigue was negligible. This tentative conclusion appears to be supported by the fractographic analysis in §6.0.

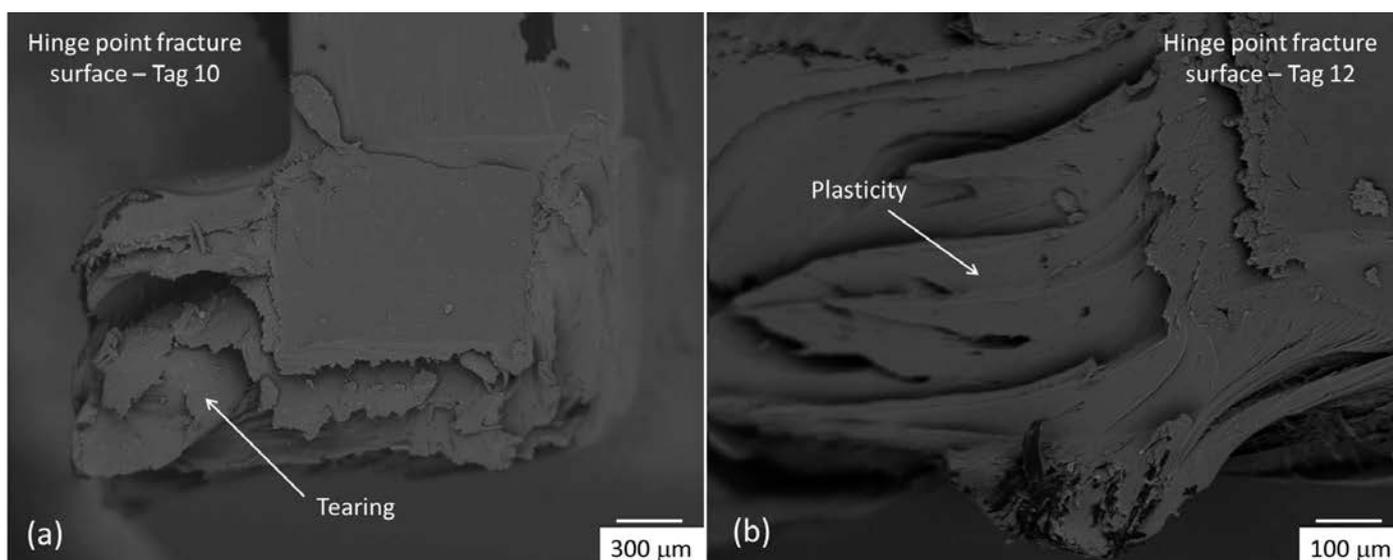
Some scanning electron microscopy micrographs are shown in Fig.17. They were obtained from TAG 4 and TAG 5, but the predominant features were observed in all of the tags tested. They show extensive local tearing and plasticity but no evidence of fatigue crack growth. There was also no evidence of conchoidal marks during examination of the fracture surface using lower resolution optical light microscopy. For instance, Fig.17 is a micrograph of a fractured arch from TAG 4. It also shows evidence of ductile fracture including a shear lip in the upper left hand corner. These observations are consistent with the observations of ductility at higher magnification.

Figure 16: Scanning electron micrographs of the hinge point fracture surfaces of (a) TAG 4 and (b) TAG 5 showing tearing and plasticity.

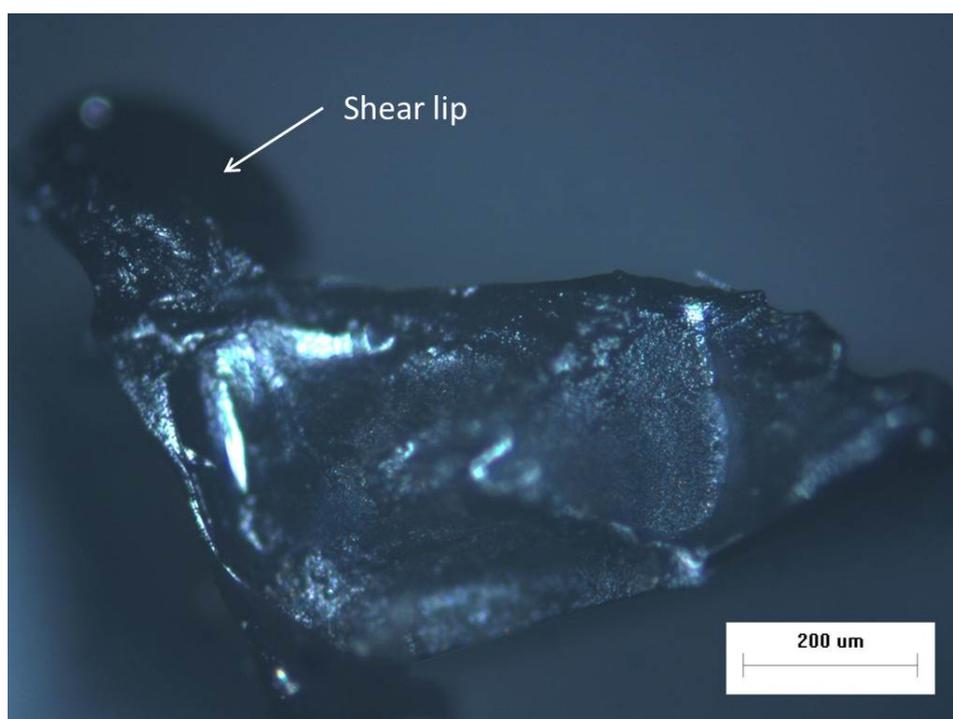
Figure 17: Optical light microscope image of a fractured arch surface showing ductile tearing and a shear lip.
