# Motorised Linear Stage PM500-1L.25 (25mm, 40mm/sec, 0.025 $\mu$ m)

Manufacturer: Newport Corporation, USA

Date of production: March 1997

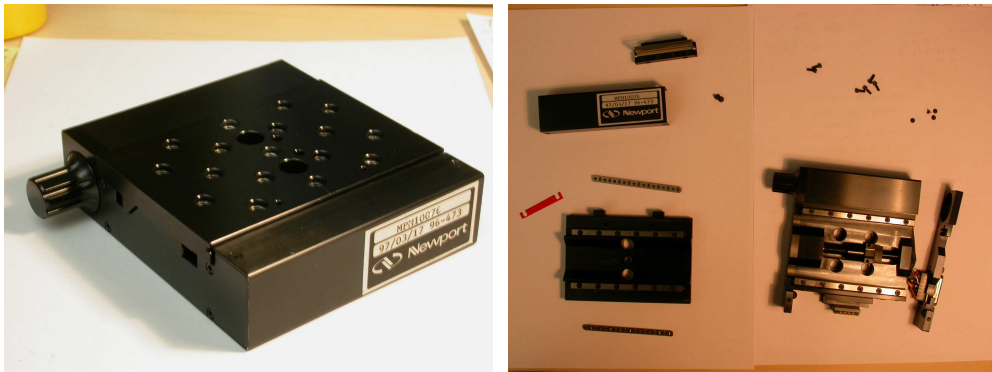
This motorised stage (picture 1a) was a part of the XYZ-stage assembly I received on loan for my hardware security research in April 2003. Unfortunately, as it always happens, this was second-hand stage out of good working condition. Firstly, the stage was producing buzzing noise when it was not moving. Secondly, the positioning of the stage was slightly non-linear. In addition I would like to have all the positioning signals coming directly from the stage for faster and easier synchronisation with my laser system.

Picture 1. The motorised stage: a) side view; b) taking it apart

The noise was due to the gap between the moving parts. Because the positioning is constantly monitored by the controller through the feedback loop such a small movements are producing buzzing noise with the frequency depending from the size of the movement and the delay of the controller circuit. Non-linearity was caused by misalignment of the glass scale encoder inside the stage.

I started with disassembling the stage (picture 1b) and learning how all the parts work together.

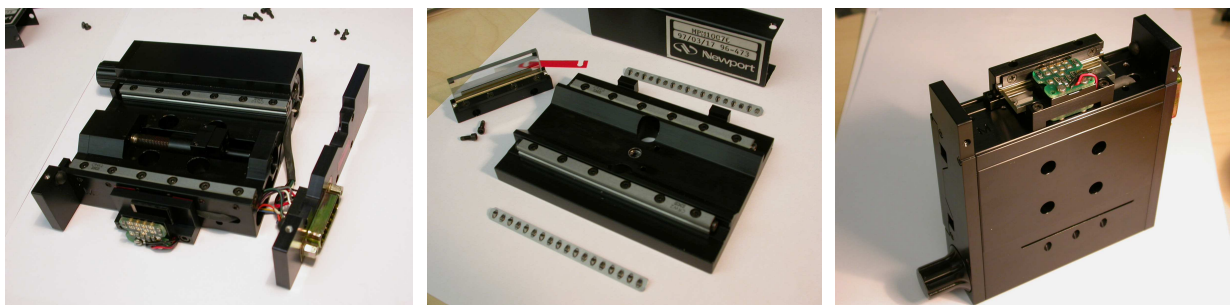
Picture 2. Taking the stage apart: a) base with controls; b) moving part with bearings; c) glass scale encoder

Unfortunately the stage had a permanent mechanical damage resulting in severe non-linearity every 2mm of movement. This is because the stage was probably dropped before it came to me. I noticed small dents on the bearing rails every 4mm on each side, but it is impossible to fix that problem without replacing the rails. If the stage is stopped within 50-100 $\mu$ m from these dents it starts producing buzzing noise caused by the feedback loop that tries to keep the stage in the desired position.

The gap between moving parts was reduced by unscrewing, repositioning and tightening the bearing rails (picture 2b). To align the glass scale encoder (picture 2c) I unscrewed and repositioned the glass scale holder unit until the signal from the encoder became linear along the whole moving range and had the same amplitude. That was observed with an oscilloscope. I put small plastic washers to slightly change the position of the glass encoder and to achieve better signal quality.

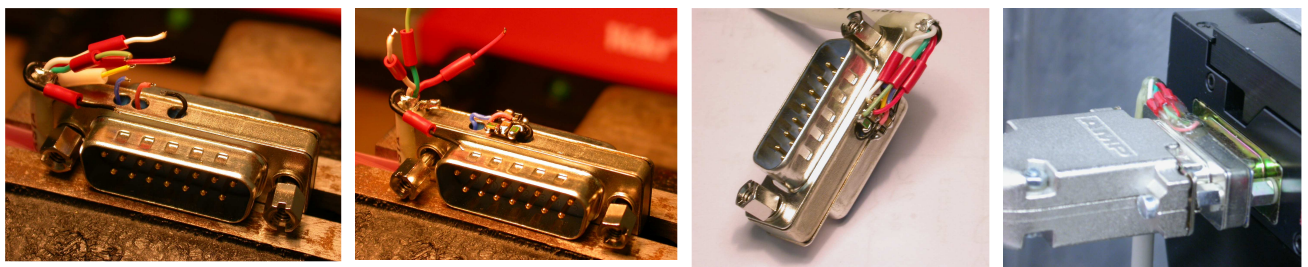
Picture 3. Building signal eavesdropping circuit: a) taking signals out; b) soldering OpAmp IC circuit; c) assembled module; d) connected module

To get the positioning signals out of the stage interface I built the buffer circuit (picture 3) based on MXL1013 Operational Amplifier mounted on the port saver connector. This was necessary because all the signals coming from the stage position encoder are not buffered. This module then goes between the controller cable and the stage connector (picture 3d).
