The University Church of Saint Mary the Great

The 1788 Peal Board

The Restored Peal Board

Some Notes on its Construction and Conservation

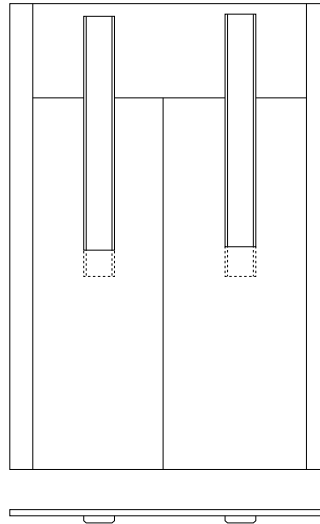
Fig. 2 — Rear Elevation and Plan of the Peal Board

The figure is to scale and shows a number of asymmetries. The narrow panels are not quite the same width and the two large vertical panels are not the same width either.

Wood is an anisotropic material and the dimensions along the grain and across the grain are affected differently by changes in temperature and humidity. Accordingly, it is regarded as bad practice to have a large panel with its grain running at right-angles to the grain of other panels abutted to it. Fortunately, mahogany is a very stable timber and there is no sign that the top panel has parted from the lower panels.

Notwithstanding the poor quality of the glues and the absence of a frame, there is little sign that the panels are separating. Moreover the five panels form a remarkably flat whole, both front and back.

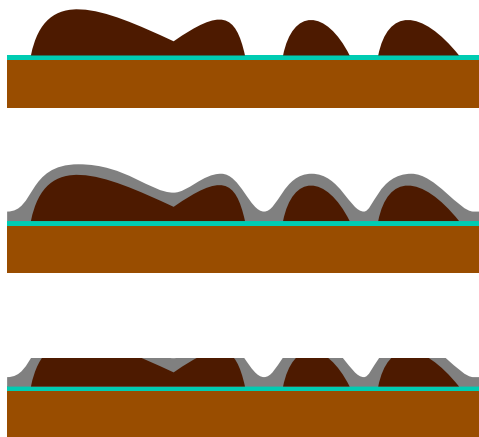
Fig. 10 — Blobs of Dark Varnish

Varnish is less elastic than oil paint and while small changes in dimension caused by variations in temperature and humidity can be accommodated by paint, varnish tends to crack and to coalesce into blobs. The appearance can be a little like that of an alligator's skin and the effect is sometimes known as alligatoring.

The top diagram in Fig. 10 shows an exaggerated cross-section of a fragment of the board. The light-brown block is the mahogany base and the thin light-blue band is the paint layer. The three dark-brown lumps are cross-sections of blobs of varnish.

Any solvent applied to the blobs in the top figure would have run into the spaces between the blobs and there would have been a danger of damaging the paint. By way of a slight paradox, Julie Crick's first step was to add another layer of varnish! This is the grey top layer in the middle diagram of Fig. 10.

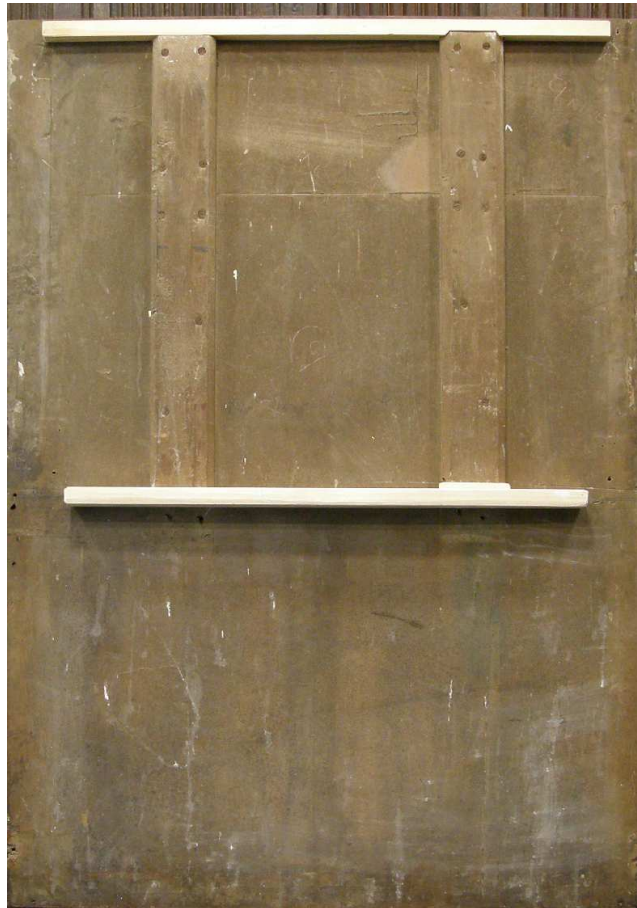
Fig. 17 — The Back of the Peal Board

Two new battens were prepared and these were fixed to the original vertical chamfered pine battens by screwing into the end-grain of the original battens. The two new battens show up clearly in Fig. 17. Note that the lower batten required a packing piece on the right and that the upper batten required a small section to be cut out on the right.

A new hanging arrangement was designed by Bo Killander and this is illustrated in the drawings in Fig. 16 and in the photographs in Figs 17 and 18. No fixtures are attached directly to the mahogany board.

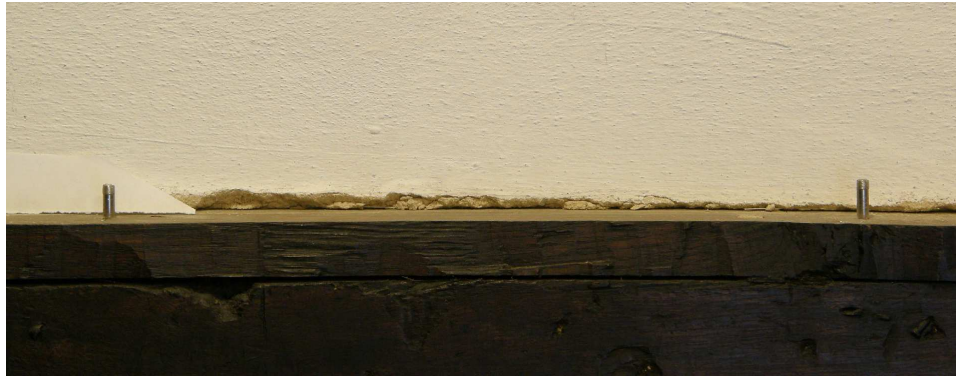
Fig. 18 — Two Pins in the Panelling

The location pins are not indicated in Fig. 16 but they can be seen in the photograph in Fig. 18 where they show up against the light background of the rendered clunch wall. These pins are screwed into the shelf that forms the top of the wooden panelling. The lower half of the photograph shows the dark wood of the panelling.

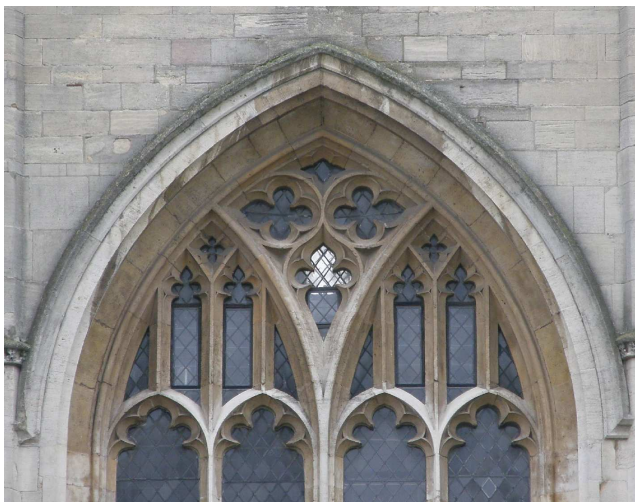
Fig. 22 — The West Window as it is

The artist has the enveloping arch a little too pointed and the details under this arch show poor attention to structural considerations. At the bottom of Fig. 22, there are four small arches, and four mullions rise up from the centres of the tops of these arches. The corresponding mullions in Fig. 23 rise up from points which are off-centre with respect to the tops of the arches and this is structurally unsound.
