# INVESTIGATION REPORT

## LANL Investigation of a Laser Eye Injury

An Accident Investigation Team (the Team), appointed by LANL Director G. Peter Nanos and working from July 19 to August 27, 2004, interviewed personnel, reviewed documents, and characterized systems and conditions in room 106. The PI reported that he was operating L1 with the Q-switch trigger cable disconnected from the Stanford Research Systems pulse generator. The Team's collected evidence confirmed that L1 could not lase under those conditions. However, because L1 *did* emit laser light on July 14, the Team believes, based on its collected evidence, that the laser was operated in one of three possible lasing modes.

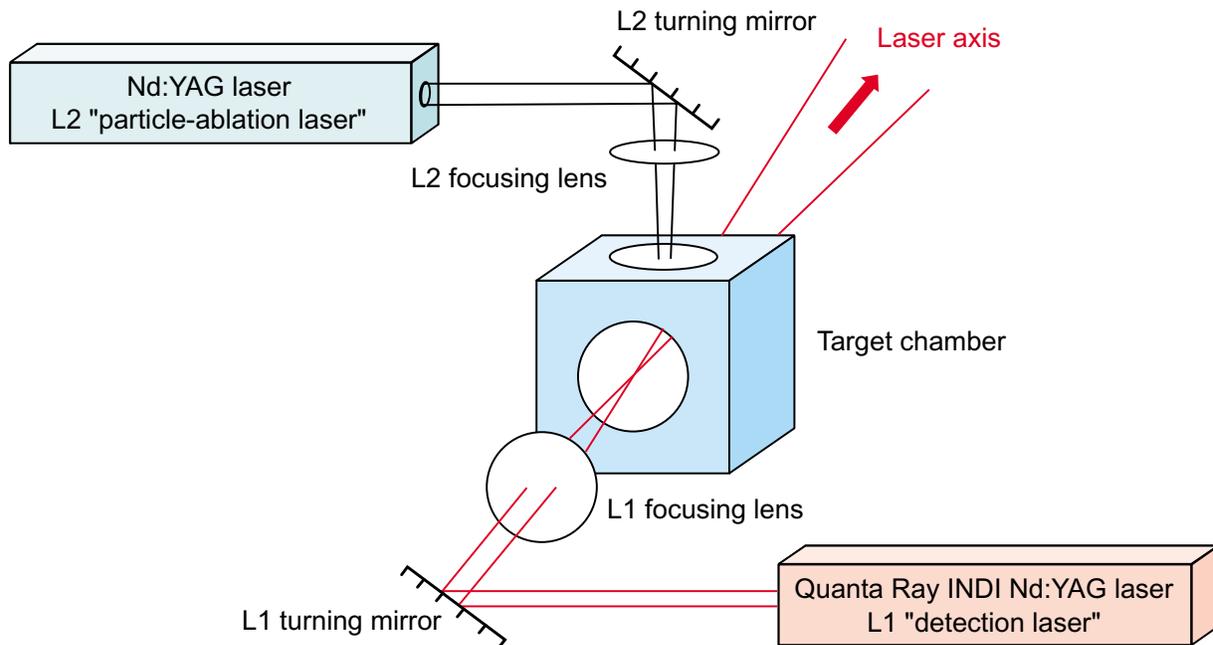
On July 13, 2004, the PI set up a new target chamber (an environmental chamber with a rear viewing window) and a second laser (an ablation laser to ablate and suspend particles). The experimental setup then involved two lasers: the original INDI detection laser, L1, and the newly introduced ablation laser, L2. Laser radiation from L1 and L2 is invisible, at an infrared wavelength of 1064 nm. The PI directed the laser paths of both lasers through the chamber with the use of turning mirrors and focusing lenses. See Figure 2.6.

Using two lasers, viewing particles in the chamber, and using L1's flash lamps for illumination were not described, evaluated, or authorized by the LIBS HCP. The Team found no record of a laser registration, Form #1552, for LI. Nor could the team find the associated hazard analysis.

Figure 2.6. A diagram of the experimental system setup, showing the beam path along the L1 axis, through the target chamber, and out the chamber's rear window.

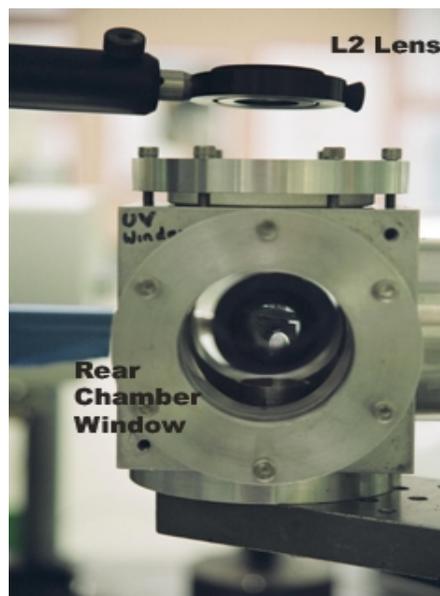
Figure 2.9 gives a view through the rear window of the chamber, back out the front window, and through the focusing lens along the beam axis toward L1.

The IWD did not describe looking into the target chamber to view particles or using L1's flash lamps for illumination. Consequently, the hazards associated with these activities were not analyzed.

Figure 2.9. A view through the rear window of the target chamber, along the beam axis, toward the L1 beam source.

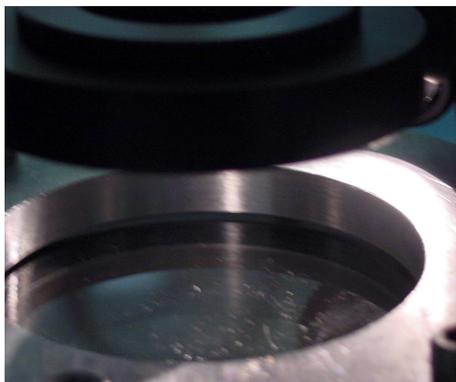
**Figure 5: Top chamber window.**

A schematic of the designed optical path and chamber is shown in Fig. 2. The definitions of the components are also shown. We first observed what looked like damage from the laser on the input and output windows of the target chamber, see Figs. 3 and 4. There was dust on the top chamber window but no damage, see Fig. 5. The turning mirror for the LIBS laser was clean and intact. The lens in front of the chamber had some dust but no damage.

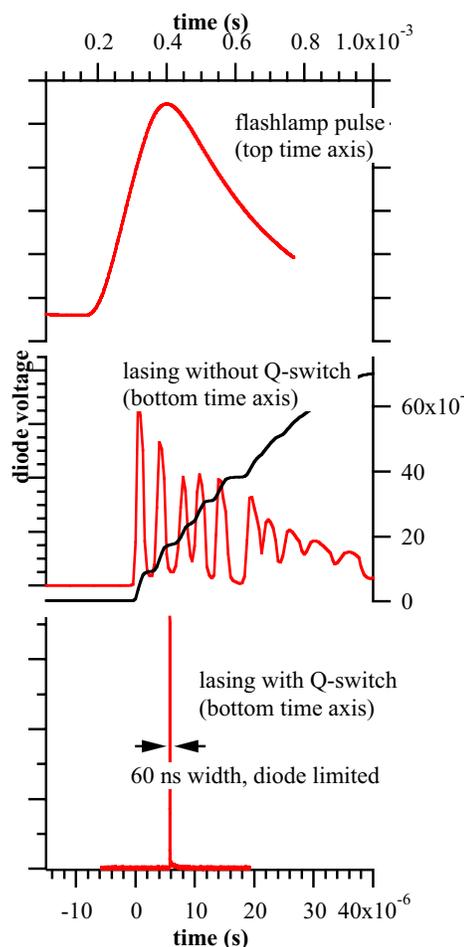
The three modes of emission by the LIBS laser are shown in Fig. 7. The data were taken on a Tektronics 740 oscilloscope, recording the voltage from a Si photodiode. The data are plotted as the voltage as a function of time. The signals from the three traces are not directly comparable in this graph. The bottom trace is the voltage recorded from a pulse obtained with the Q-switch trigger selection set to Q-switch (the mode in which the Q-switch is internally triggered). The second trace is the voltage from a free-running pulse obtained with the Q-switch trigger selection set to long pulse (the mode in which the Q-switch is held open for the duration of the flashlamp pulse). Both traces are plotted against time on the bottom axis. The pulse width of the traces in this graph is broadened due to saturation of the photodiode. The quoted width of the Q-switched pulse is 5 to 8 ns. A more-careful measurement of the individual pulse width in long-pulse mode yielded a width of 440 ns (a lower limit, as the photodiode could still be broadening the measured pulse). The top trace is voltage obtained with the Q-switch trigger selection set to EXT, without an external Q-switch trigger pulse. The laser flashlamp trigger selection was set to EXT for all measurements, with a TTL trigger applied from a Stanford Research Systems (SRS) delay generator. The top trace is plotted as a function of

The total energy in this mode is comparable to the energy in Q-switch mode (~20% higher at the same flashlamp setting) but, as shown in Fig. 7, is distributed in a series of sub-microsecond pulses (laser free running). The beam diameter at the laser is 5 mm, as measured with the Tokin SHG-type IR card.

Figure 7: The temporal shapes of all conditions. The measured Q-switch pulse width is limited by the photodiode response time.

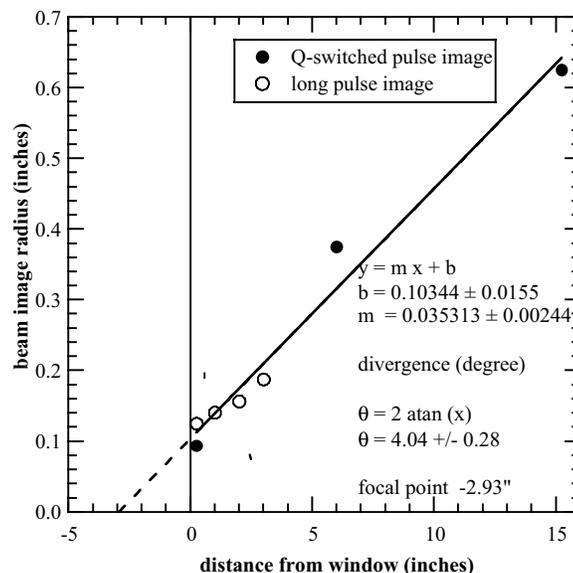
Figure 9: Far field divergence in the laser pulse.

The image radius measured in this way is shown in Fig. 9. The beam image radius in Fig. 9 is plotted as a function of the distance from the external surface of the back window on the chamber, with the image radius on the window surface plotted at 0, as in Fig. 8. The solid and dashed lines of Fig. 9 are the resulting linear fit to the data, as done for Fig. 8, and the parameters are shown in the figure as well. The beam divergence for a lasing pulse in the far field is determined to be  $\theta = 8.8^\circ \pm 1.6^\circ$  and the focal point  $x_0 = -2.2"$ . The focal point places the simmer focus approximately 2 inches into the chamber, from the external surface of the back window, or near the center of the chamber.

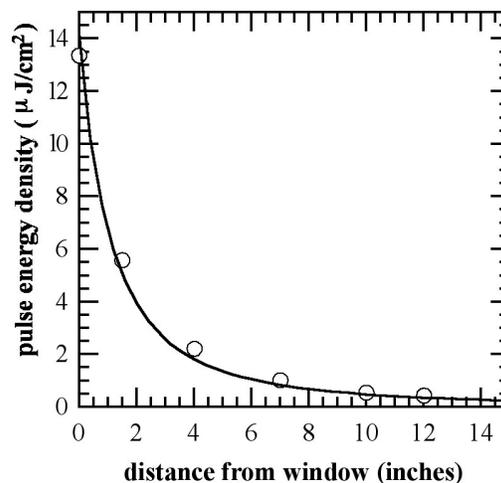
**Figure 11: Energy density as a function of distance from the back chamber window for the simmer pulse.**

the energy measurements was set to full. A position index of the energy measurements made for the simmer pulse is shown in Fig. 10. These data were then divided by the aperture area of the energy meter used, or  $0.95 \text{ cm}^2$ , to yield the energy density as a function of position past the back chamber window. The data are plotted in Fig. 11 as a function of distance behind the back chamber window, with the external window surface at  $x = 0$ , as before. The solid line is a calculation of the energy density,  $E$ , as a function of the same distance from the back chamber window,  $r$ , using  $E = E_0 (r_0/r)$ , where  $E_0$  is the energy density at the external surface of the window, with image radius  $r_0$ .

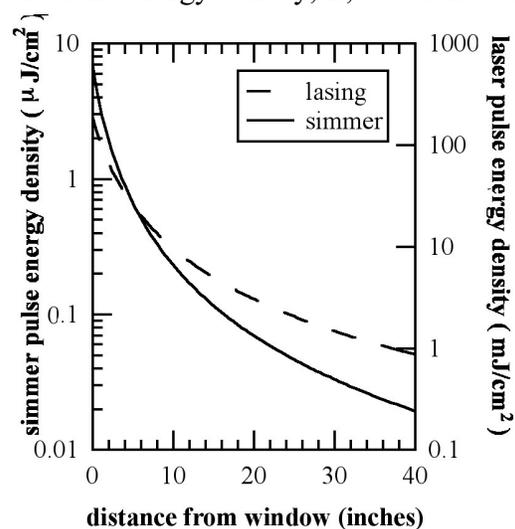
The calculated energy density as a function of position is shown in Fig. 12 for both lasing and simmer modes. The distance scale is referenced to  $x = 0$  at the external surface of the back chamber window, as before. The calculation is for threshold emission, with the flashlamp voltage set at the minimum threshold to produce a laser pulse (as indicated on the laser with a pencil mark).

Figure 12: Calculated energy density as a function of distance from the back chamber window for both simmer and laser pulses.

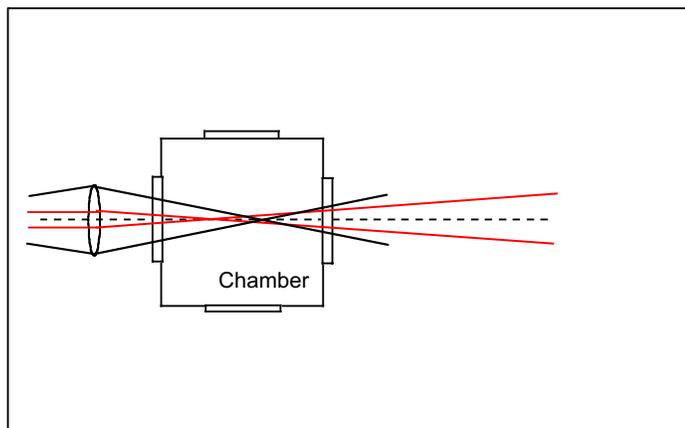
The divergence of the simmer and laser beams is shown schematically in Fig. 13. The height of the center of the beams was measured to be 48" at the back chamber window and 59" at the back wall, which is 83" horizontally from the back chamber window.

Figure 13: Schematic of the beam divergence in the far field. The red lines depict the laser beam path and the black lines the simmer light.

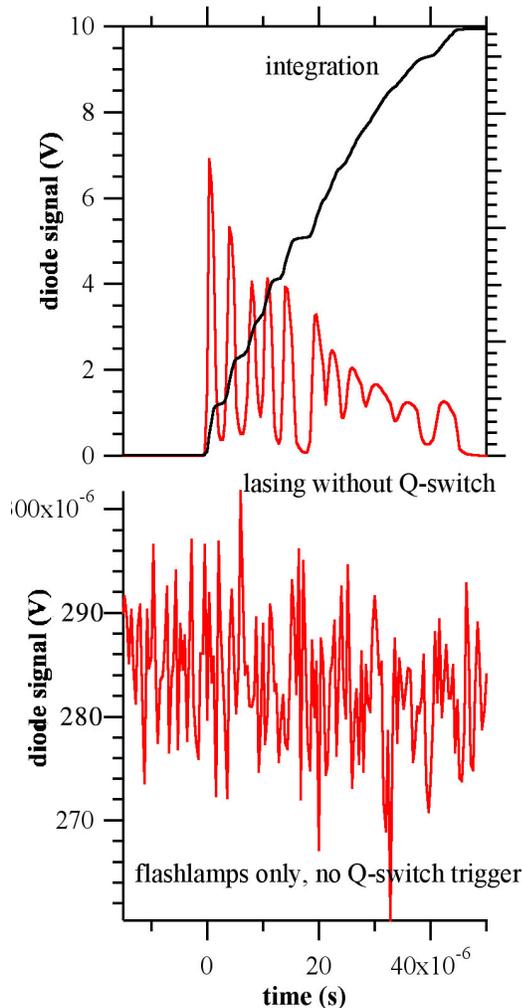
7 V was measured while using a long pass filter, RG 850, as well as the 1064 nm dichroic turning mirror in order to discriminate against the simmer light and optimize the sensitivity to measuring a laser pulse. The Q-switch trigger selection was then set to EXT, and measurements of the baseline were made. No laser pulse was observed in this manner over the entire time period of the laser duty cycle and particularly not during the duration of a flashlamp pulse. Results of the two experiments are shown in Fig. 14. Using an integrated intensity for the long-pulse-mode laser pulse of 40 mJ and noting that the leading pulse in the long-pulse train is approximately 10% of the energy leads to a value of 4 mJ for the energy of a single pulse in long-pulse mode or a conversion factor of  $6 \times 10^{-4}$  J/V. The measured baseline in Fig. 14, obtained under the same conditions as the long-pulse data, gives a baseline sensitivity of 10  $\mu$ V or an upper limit to any laser pulse present of 5 nJ.

This laser emitted laser pulses only sporadically.

At the laser head, we were able to directly measure the pulse power of only a few pulses and found them to be approximately 300  $\mu$ J per pulse, which was just above the limit of sensitivity for our detector. We saw only 3 pulses in approximately 10 minutes. The laser is apparently just at the threshold for lasing, and due to the sporadic nature of its emission, we were unable to characterize its divergence characteristics. We expect the pulses to be approximately 10 ns long.

**Figure 14:** The long pulse signal on a Si photodiode is shown in red. The signal is plotted in volts. The black line is the integration of the signal. The zero amplitude measurement made in search of a lasing condition is shown in the bottom panel.
