Curfew Tags: Mechanical Fatigue Tests

Reference: DPC/010/Fatigue/Issue1

James Dean

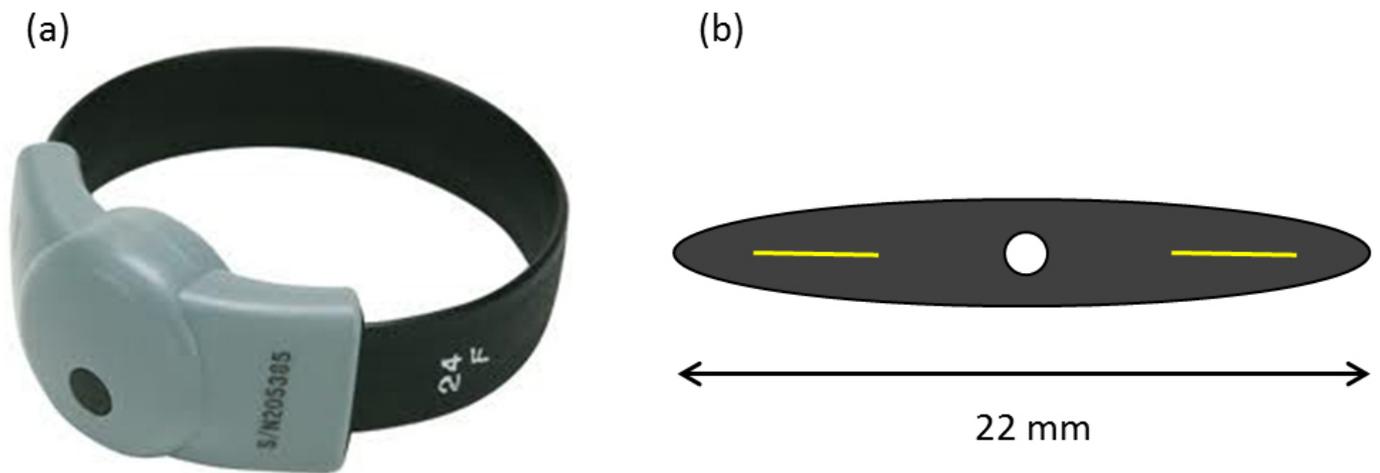
A curfew tag is shown in Fig.6. It consists of a rubber strap, reinforced by thin Kevlar™ fibres as in (b). There is a clip at each end of the strap that appears from inspection to be injection moulded. In Fig.6(a) they are hidden inside the plastic casing. The clip material is polycarbonate – confirmed by infra-red spectroscopy tests conducted in the Polymer Laboratory at Cambridge University. The transmission versus wavelength trace is shown in Fig.7.

Figure 6: A curfew tag is shown in (a). The cross section of the curfew tag strap is shown in (b). The reinforcing fibre, which runs along the axis of the strap, is also shown – as is the channel down which the optical fibre runs.

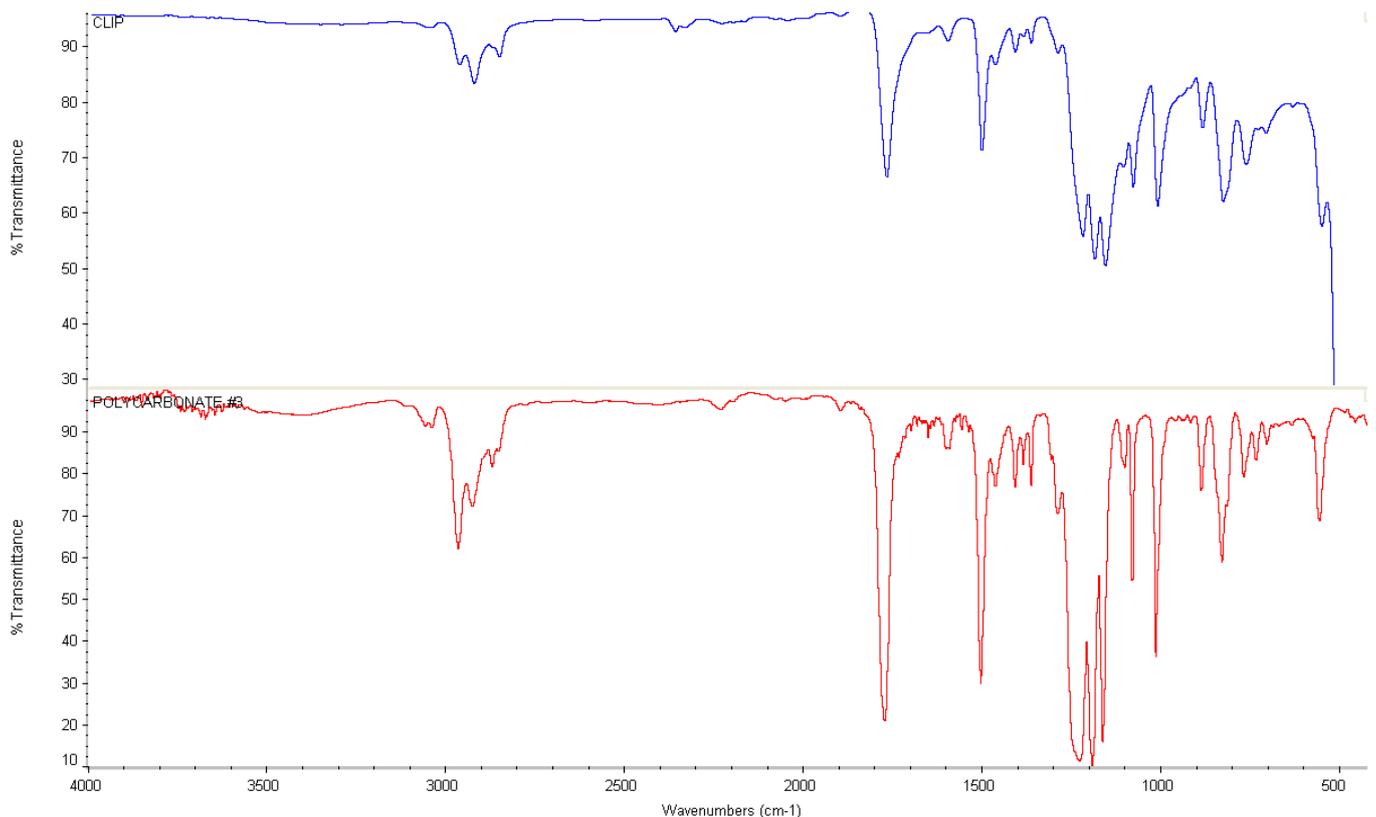
Figure 7: Transmittance versus wavenumber data obtained from infra-red spectroscopy tests on a sample of clip material (upper curve) and a corresponding trace from a known polycarbonate (lower curve).

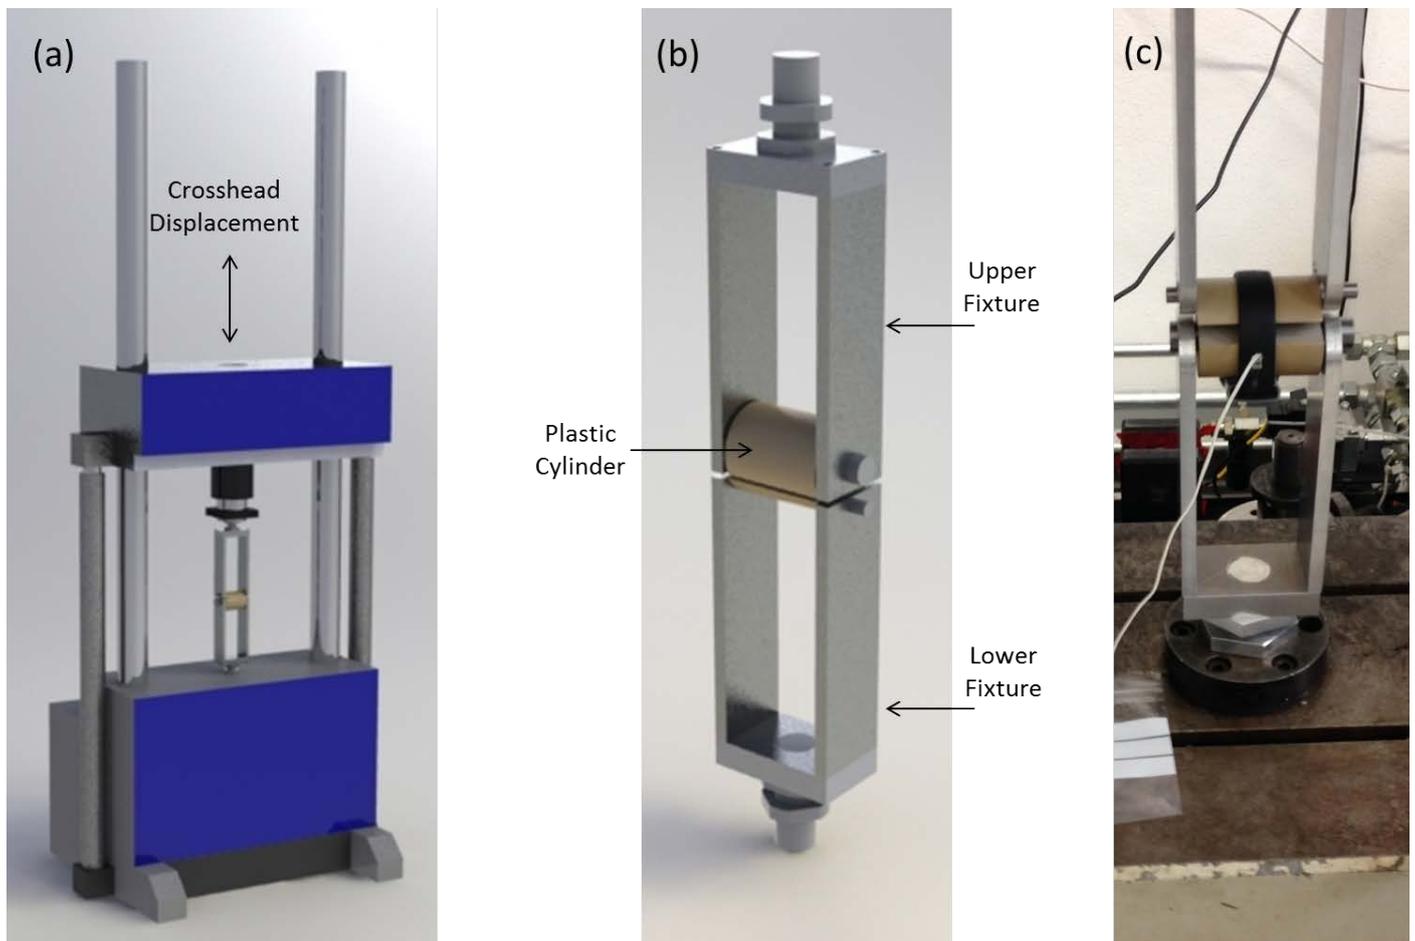
Figure 10: Shown in (a) is a 3D-rendered image of the mechanical loading frame. Shown in (b) is a 3D-rendered image of the purpose-built mechanical grips. The photograph in (c) shows a curfew tag ready for testing.

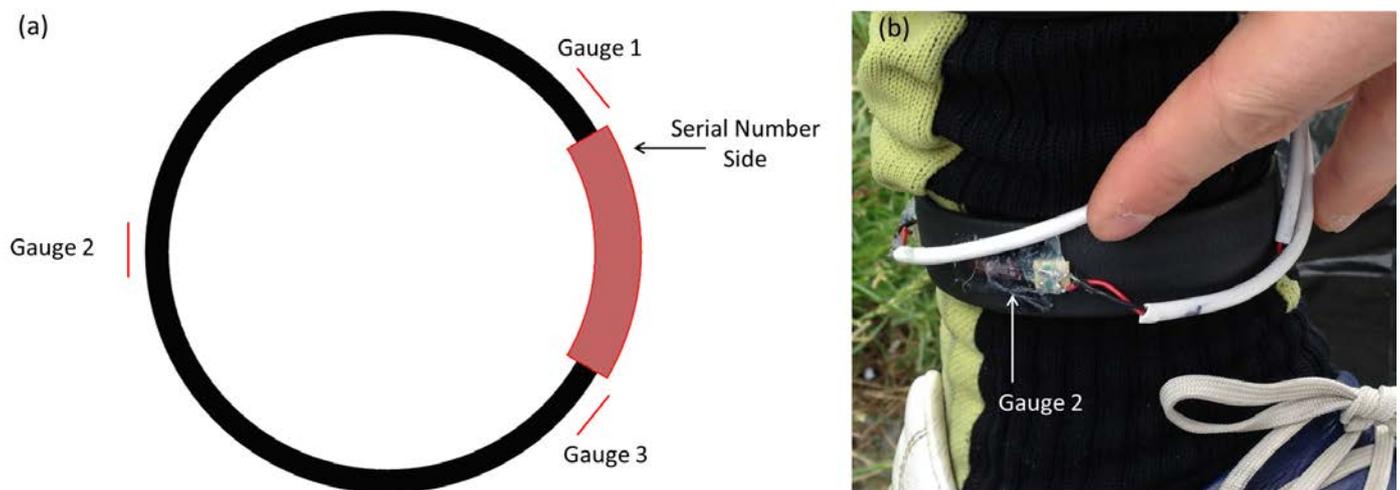
Figure 11: The positions of the strain gauges are shown in (a). Strain gauge 1 was always positioned at the serial number side of the tag. An instrumented tag is shown in (b).

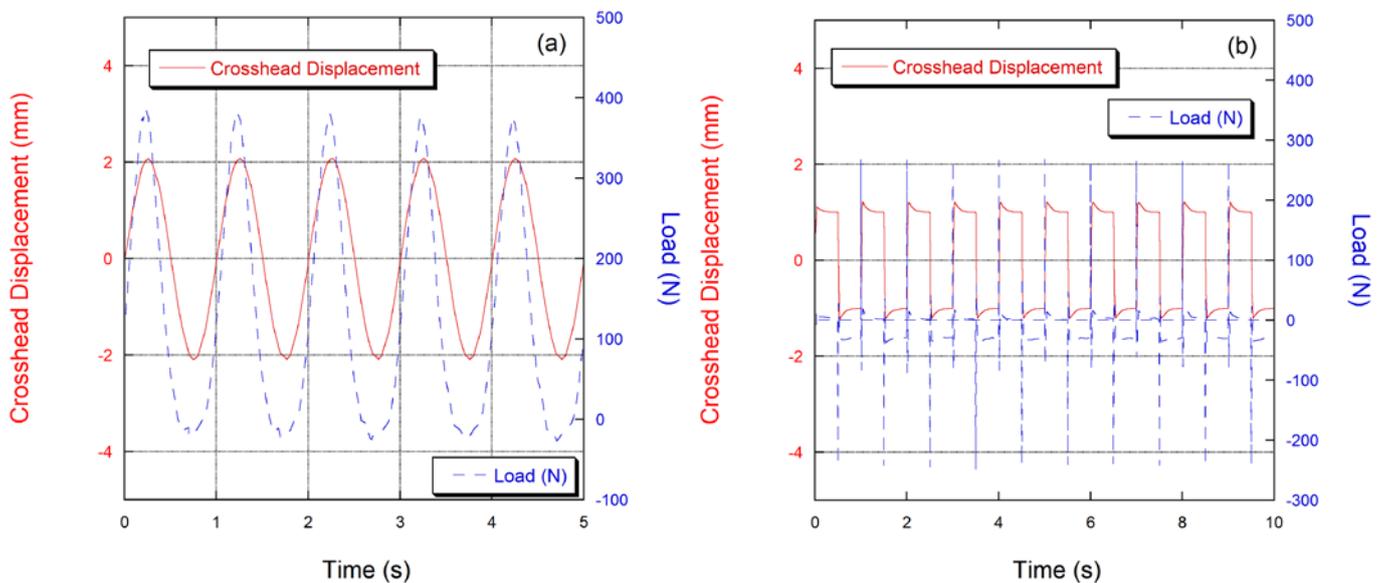
Figure 12: The imposed sine-wave amplitude history for tests conducted on TAG 3 and the corresponding (measured) loads are shown in (a). The first five seconds of the test are shown. 1800 of these cycles were imposed in total. The imposed square-wave amplitude history for tests conducted on TAG 4 and the corresponding (measured) loads are shown in (b). The first ten seconds of the test are shown. 1800 of these cycles were imposed in total.

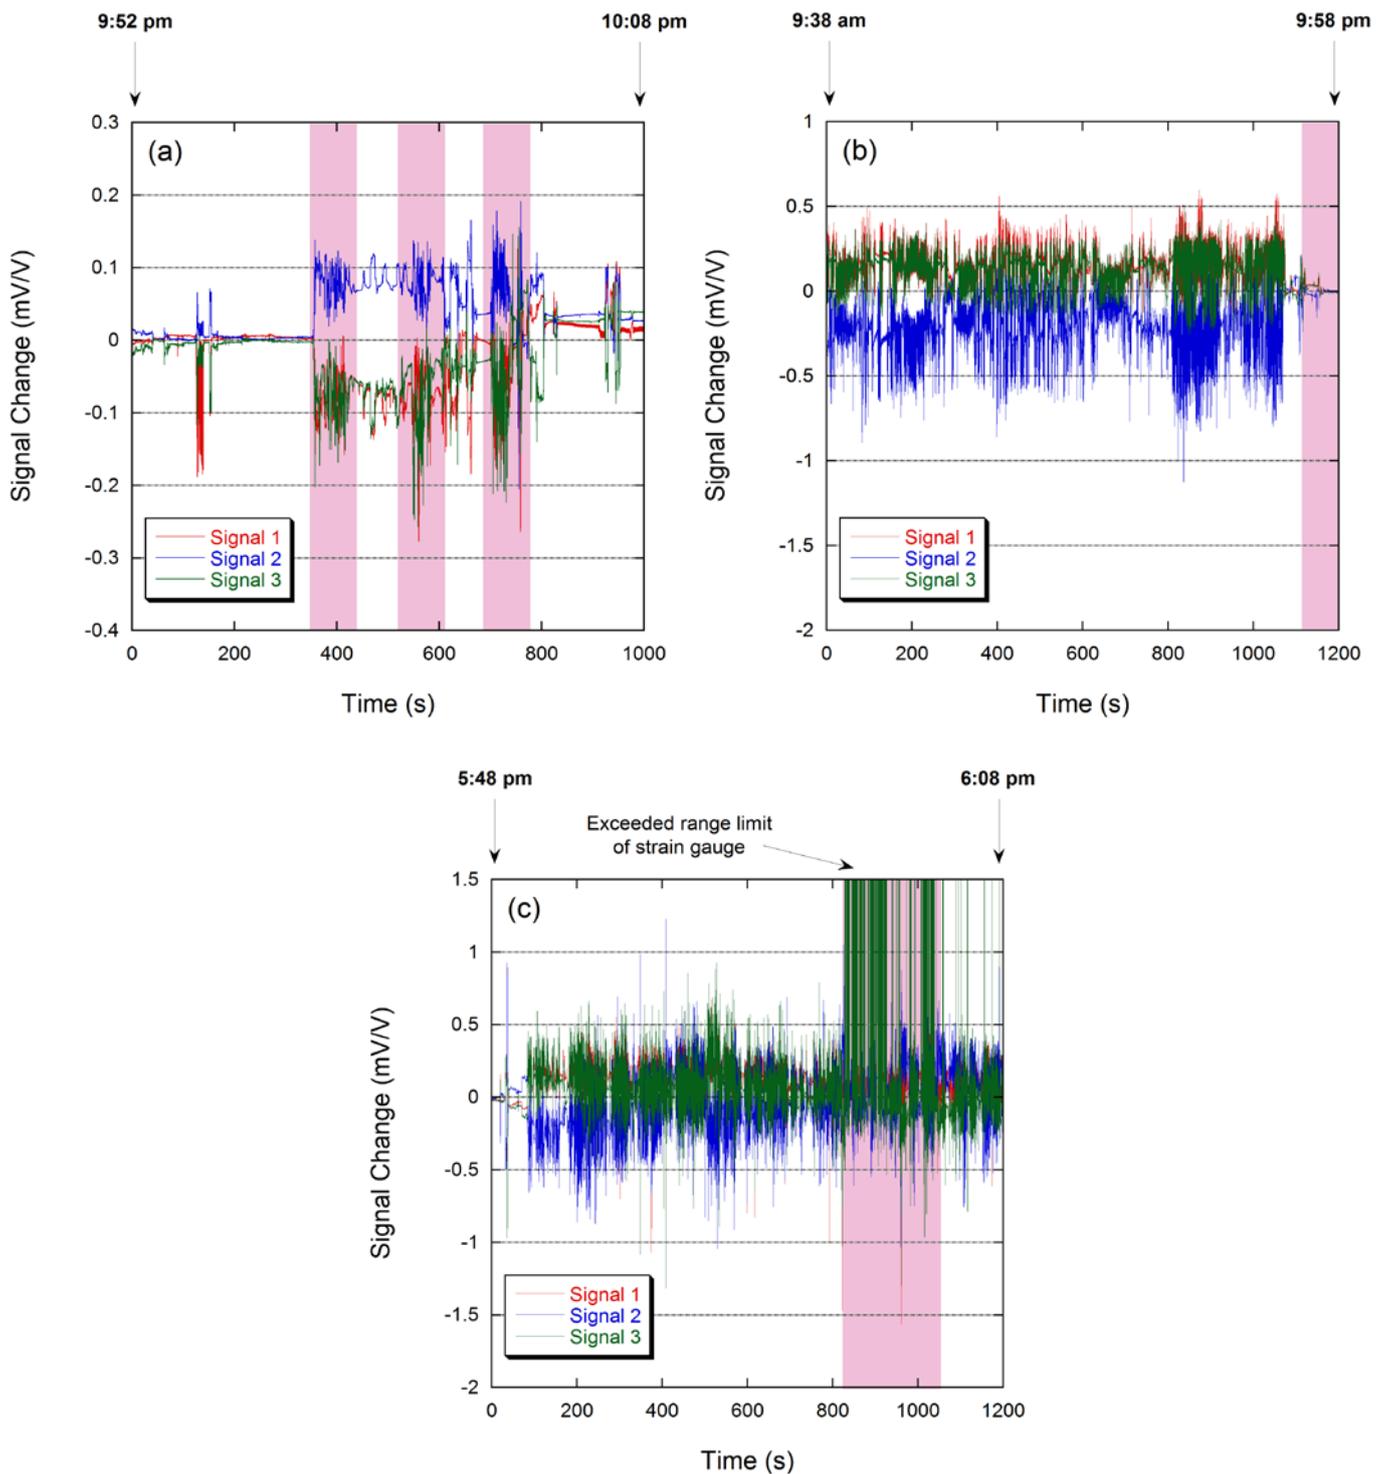
Figure 13: Measured strain gauge signal data obtained by Saad al-Oteibi and James Dean while (a) praying, (b) cycling and (c) playing football.

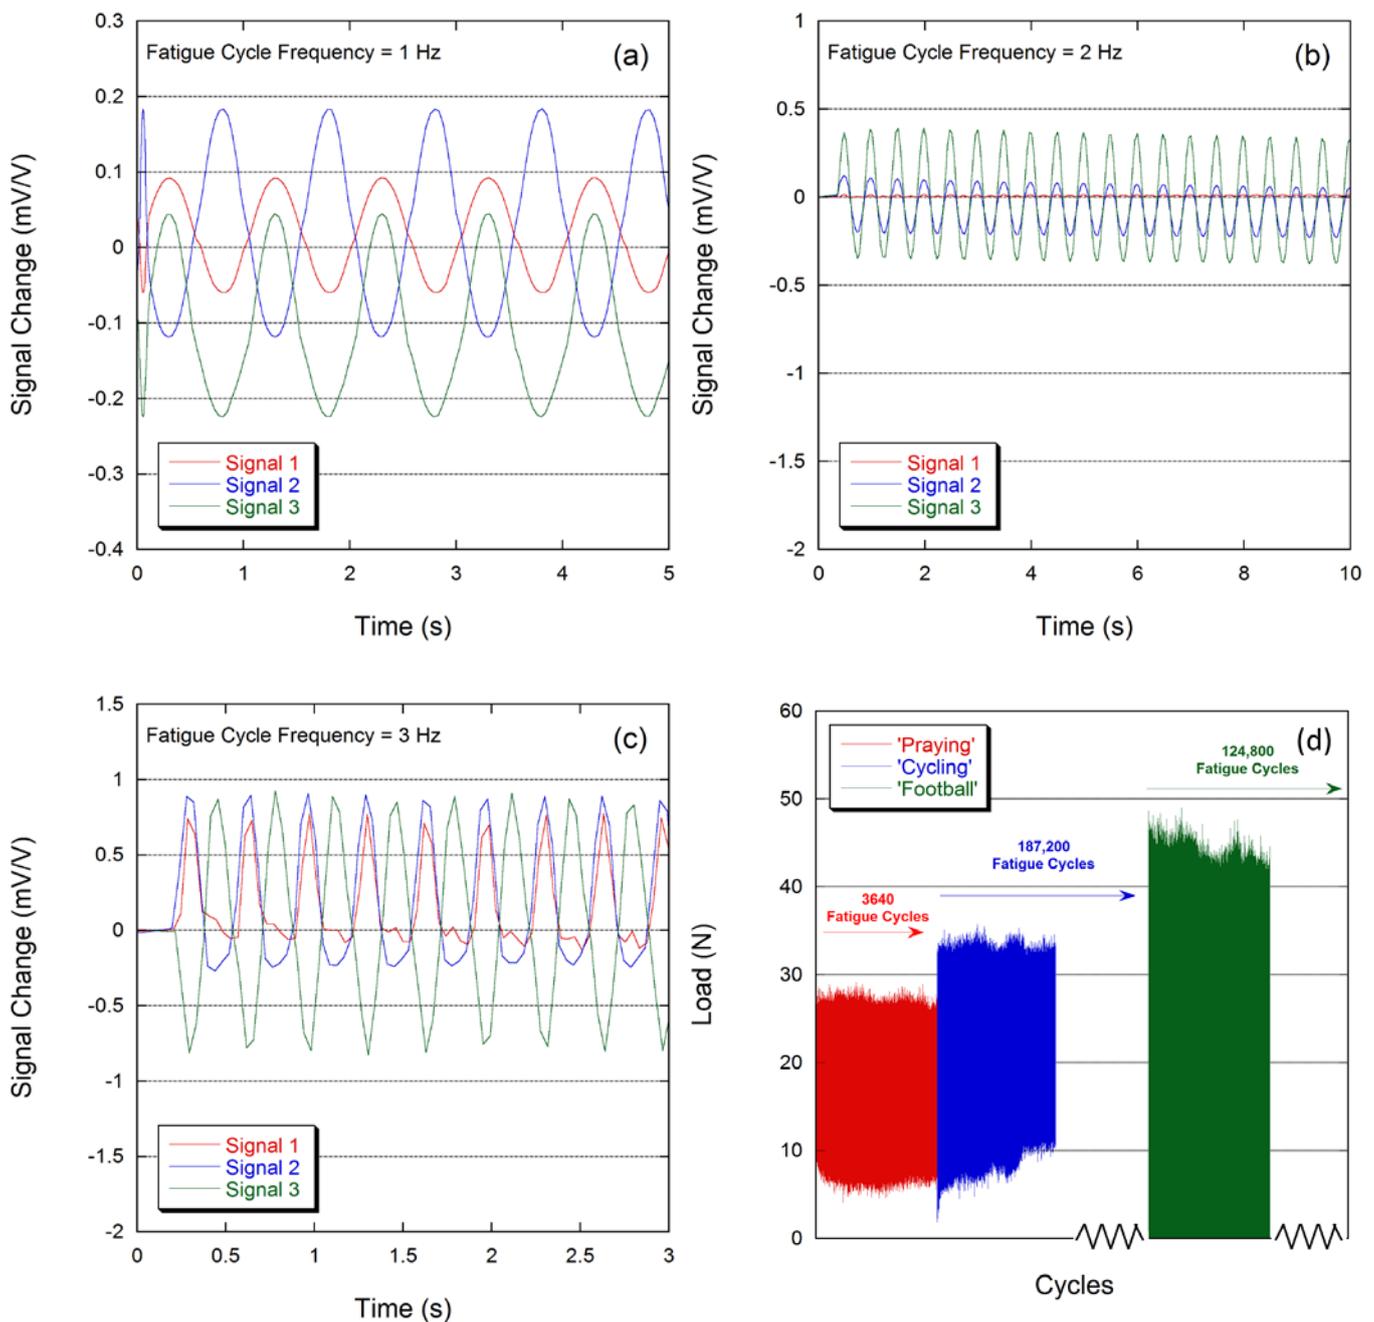
Figure 14: Measured TAG 5 strain gauge signals. The signals in (a) were obtained during simulated prayer cycles. The signals in (b) were obtained during simulated cycling cycles. The signals in (c) were obtained during simulated football cycles. The corresponding TAG 5 loading history is shown in (d).

It should be noted that the amplitude histories imposed on TAG 5 that yield the strain gauge signal changes in Fig.14 can only approximately reflect the loading histories experienced by tags in service. The measured signal change histories in Fig.13 are far more random than can be generated in the laboratory and they almost certainly include an element of strap twisting and rotation. These effects are difficult to replicate experimentally although the signal change histories in Fig.14 are reasonable approximations. Furthermore, the corresponding (measured) loading histories in Fig.14(d) are sensible and don't exceed 5 kg, which provides some confidence in this approach.
